Salmon Trout River

WATERSHED MANAGEMENT PLAN

**Water Quality Protection, Habitat Restoration
and Pollution Prevention**

July 2007

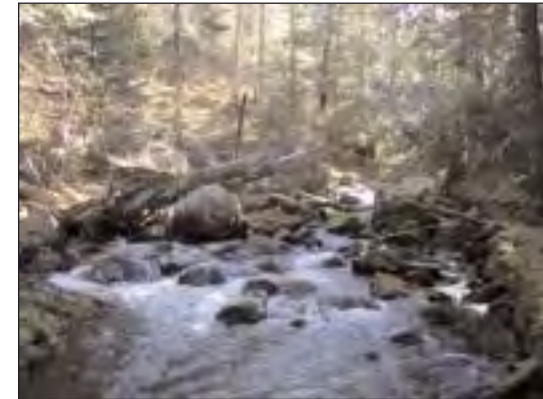
East Branch of the Salmon Trout River

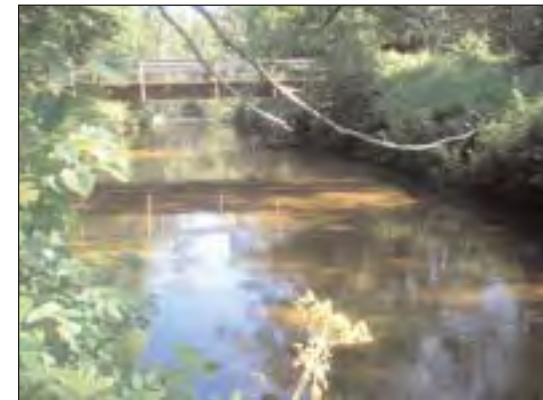
Main Branch of the Salmon Trout River

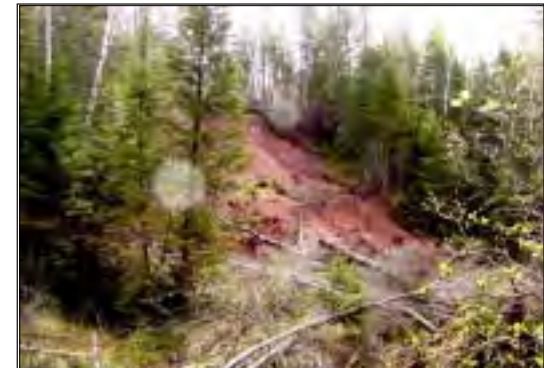
Stream bank erosion site on the Main Branch of the Salmon Trout River near the Lower Falls.

While steep gradients make stream reaches in the upper watershed vulnerable to erosion, most banks are well vegetated and remain stable. There are only two sites in the watershed that are known to have experienced major stream bank erosion not associated with a road/stream crossing. Both are naturally occurring and are located near the Lower Falls in an area that is accessible only by foot. One site consists of a large-scale bank failure that was likely a result of a significant run-off event in an area with steep slopes and soils that highly vulnerable to erosion. The other is quite minor in comparison and while this site remains un-vegetated, it appears to be stable and not a significant source of sedimentation to the Salmon Trout River.

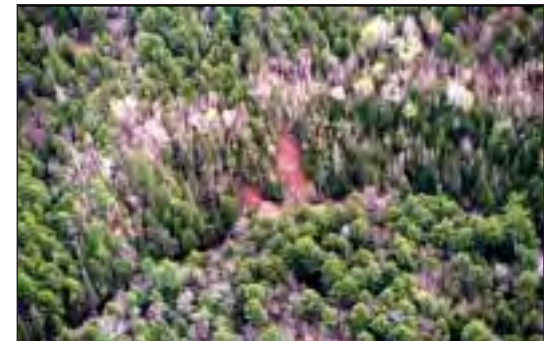
Aerial photograph of the same site on the Main Branch.

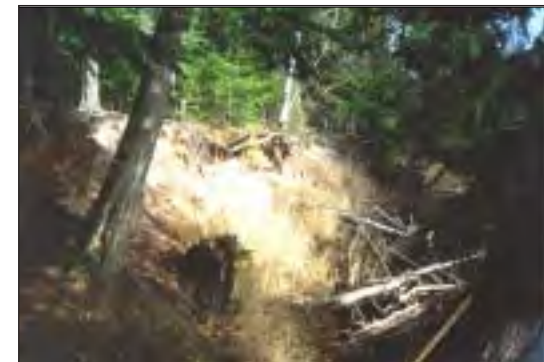
Additional stream bank erosion site on the Main Branch near the Lower Falls.

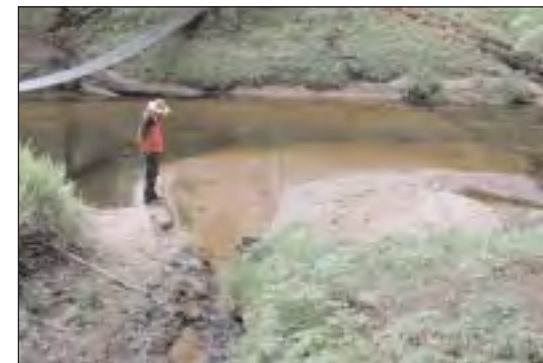
Sand delta at the mouth of Murphy's Creek

There are several low gradient reaches in the Salmon Trout River that pass very little of the sediment input they receive, and thus act as traps or storage areas. This is especially true in the lower river from the Lower Falls to the mouth at Lake Superior, where stream channel gradient is very low. This reach stores a large volume of sediment both in the channel bed and banks. Bed sediment in this reach typically exceeds one foot in depth. Sand bars are also frequently seen, further indicating a positive net sediment budget (sediment entering is less than sediment leaving). Most of this sediment is believed to originate from upstream sources. However, Murphy's Creek, a small intermittent tributary to the lower Salmon Trout River, may also contribute sediment to the Main Branch of the Salmon Trout River. Sediment loads from this source were not calculated because of intermittent flows and an unknown history of events.

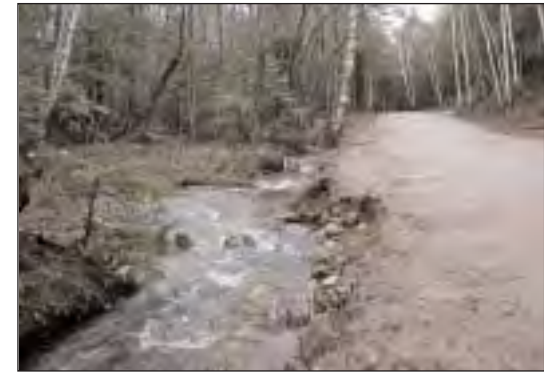
East Branch of Salmon Trout River along County Road AAA

sediment control measures, many others are still acting as direct sediment inputs to the system. Among the worst of these crossings are the three crossings of the East Branch of the Salmon Trout River by County Road AAA (Triple A) in Champion Township. These crossings consist of single culverts that are of insufficient diameter and length. In addition, the stream meanders under the road three times in less than 1/2 mile in this area, resulting in large amounts of sediment input to the stream bed, especially during snow melt, rain events, and road grading operations. Similarly, the nearby crossing of the East Branch by the Northwestern Road consists of dual culverts that are also of insufficient diameter and length. In addition to severely eroding road slopes, this crossing is overwhelmed by spring run off, which forces the river to flow over the road, washing tons of sediment into the stream.

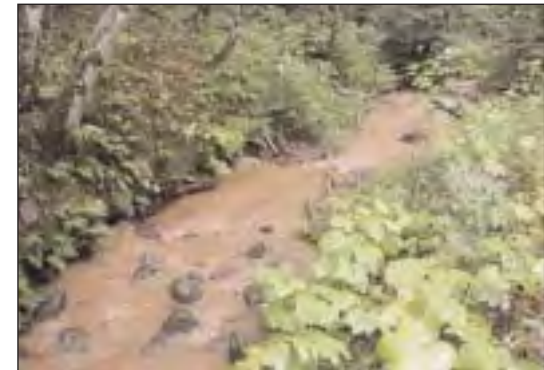
East Branch of Salmon Trout River during rain event

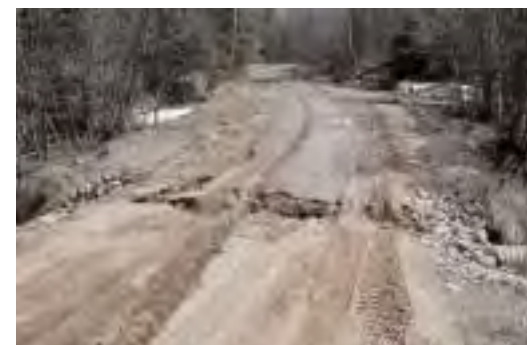
Site#16 before improvement

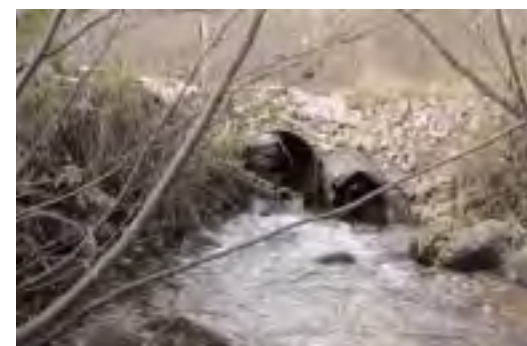
Site#16 culverts before improvement

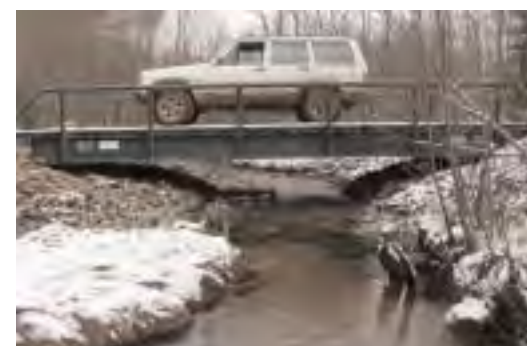
Site#16 crossing after improvements

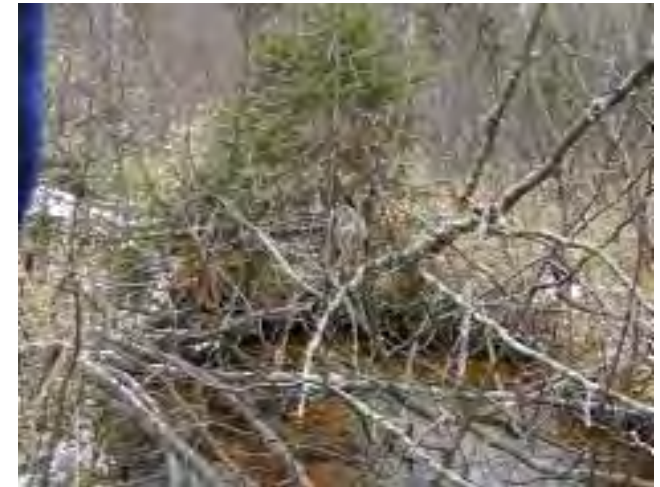
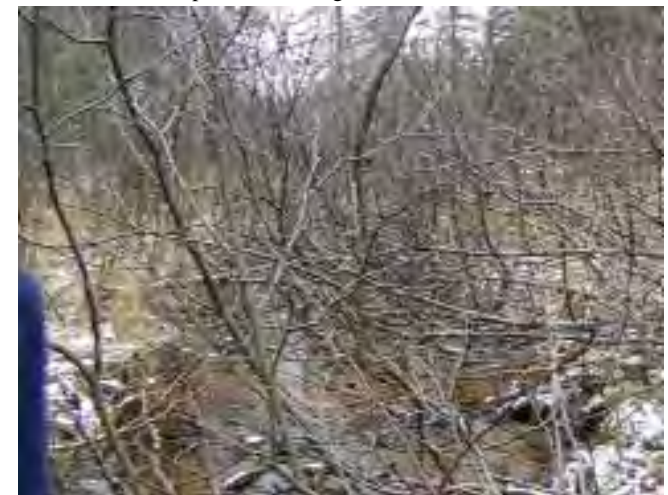
Salmon Trout River Monitoring, November 2004.
 Site #1 Main Branch Salmon Trout River

Downstream looking upstream

Upstream looking downstream

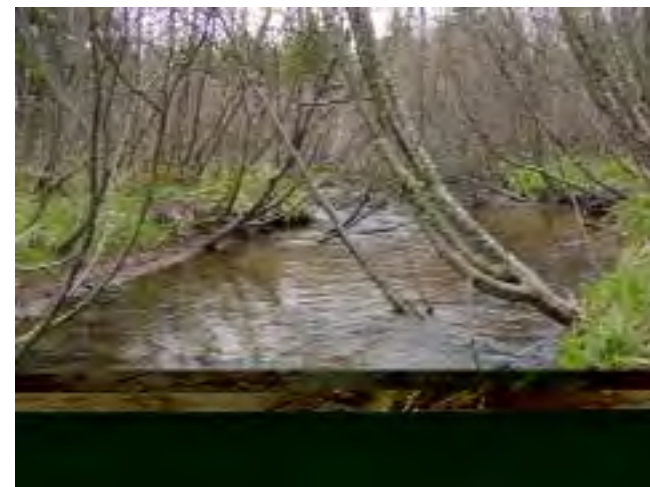
Salmon Trout River Monitoring, May 2005.
Site #3 East Branch Salmon Trout River

Downstream looking upstream

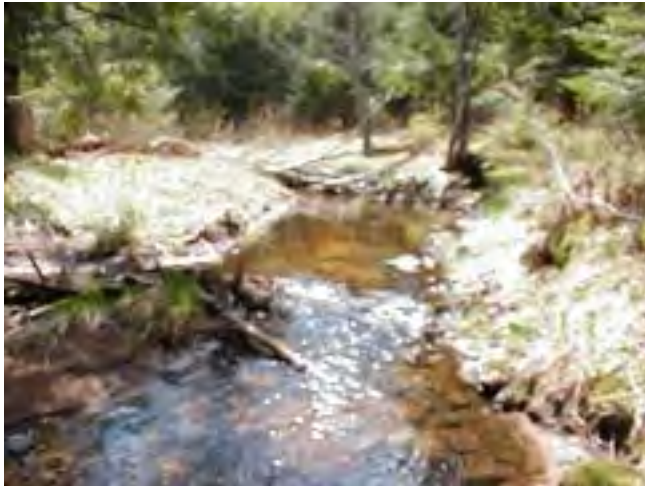
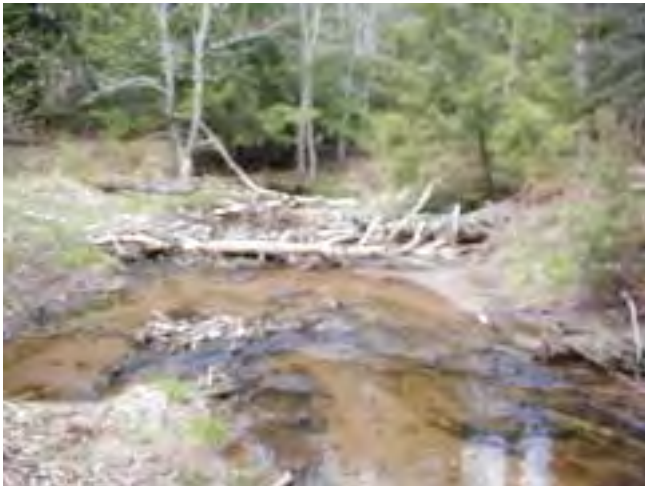
Salmon Trout River Monitoring, May 2005.
Site #4 Snake Creek

Downstream looking upstream

Upstream looking downstream

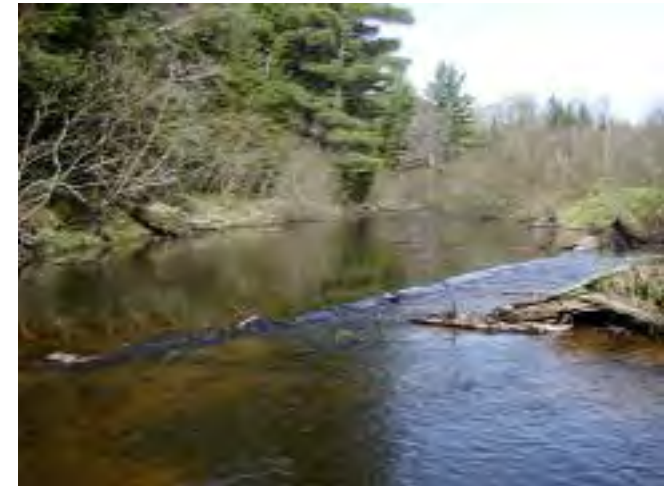
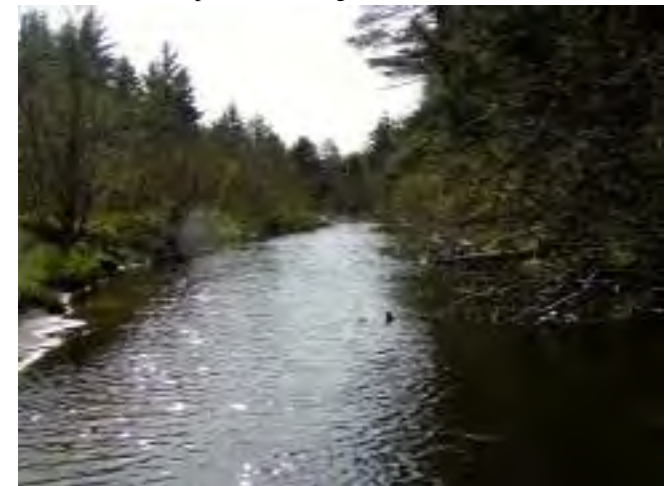
Salmon Trout River Monitoring, May 2005.
 Site #5 Salmon Trout River

Downstream looking upstream

Upstream looking downstream

Comments: Water is very cold here today. No new beaver chews noted. Many holes over 3' deep, station average depth is about 2.5'.

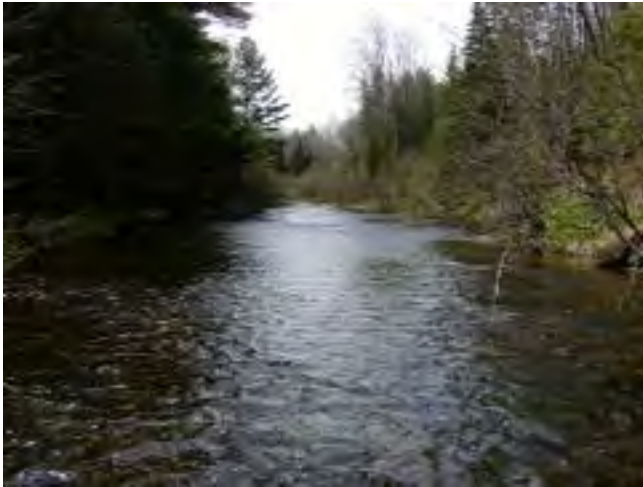
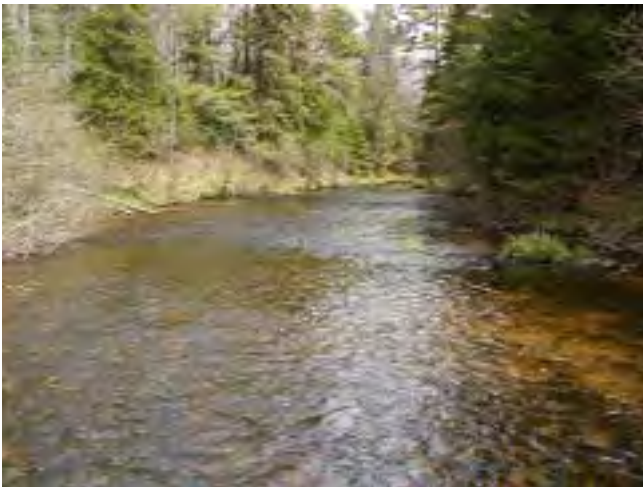
Salmon Trout River Monitoring, May 2005.
Site #6 Main Branch Salmon Trout River

Downstream looking upstream

Upstream looking downstream

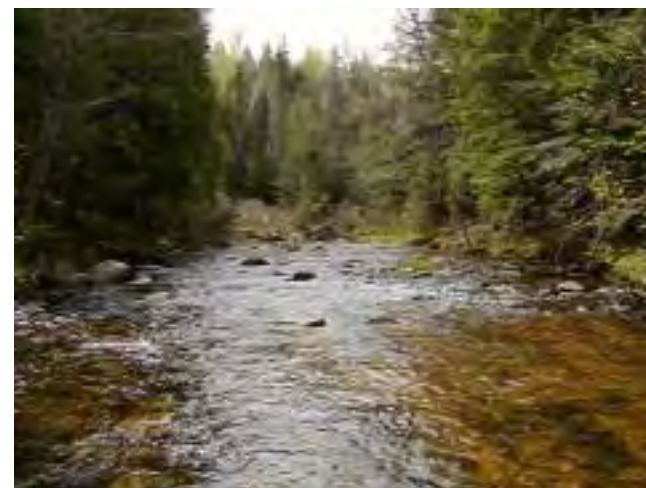
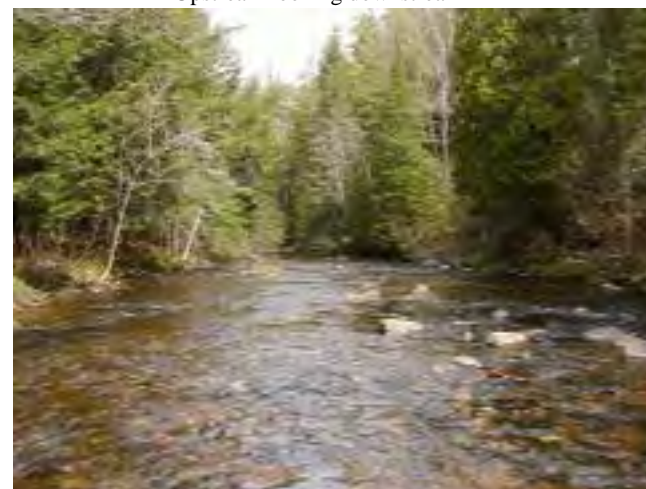
Salmon Trout River Monitoring, May 2005.
 Site #7 Main Branch Salmon Trout River

Downstream looking upstream

Upstream looking downstream

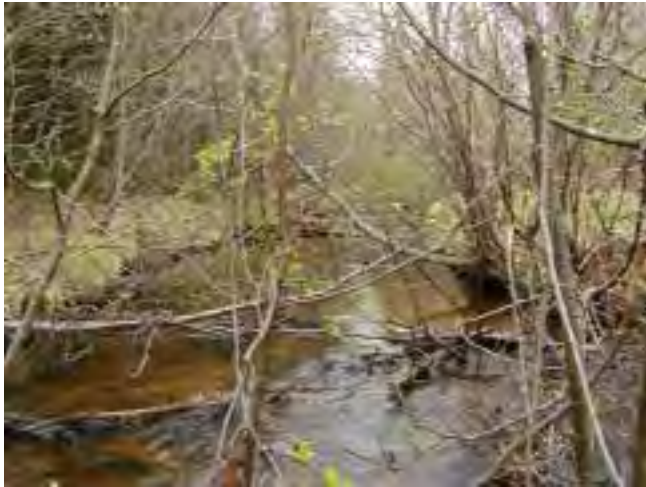
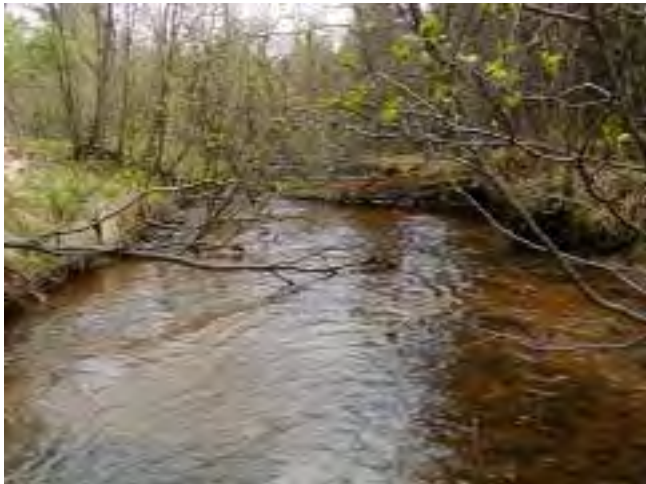
Salmon Trout River Monitoring, May 2005.
Site #8 Main Branch Salmon Trout River

Downstream looking upstream

Upstream looking downstream

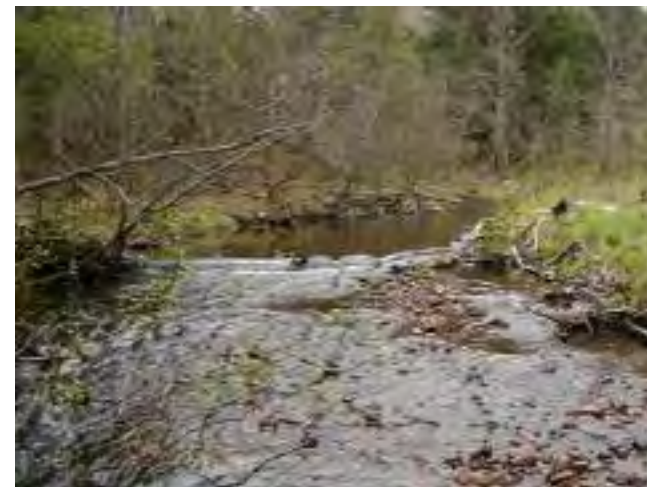
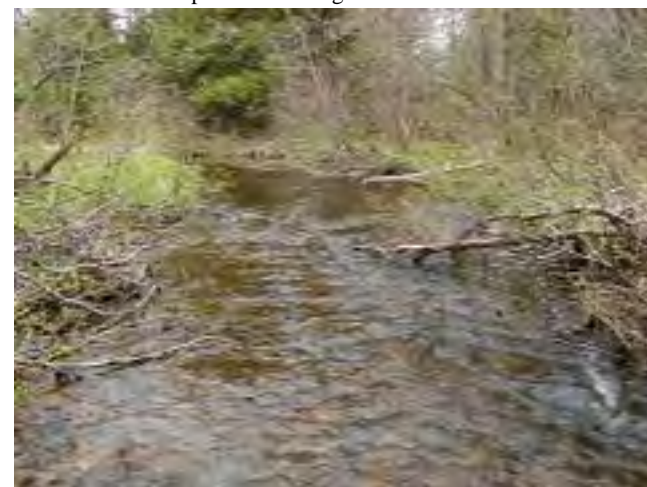
Salmon Trout River Monitoring, May 2005.
Site #9 Main Branch Salmon Trout River

Downstream looking upstream

Upstream looking downstream

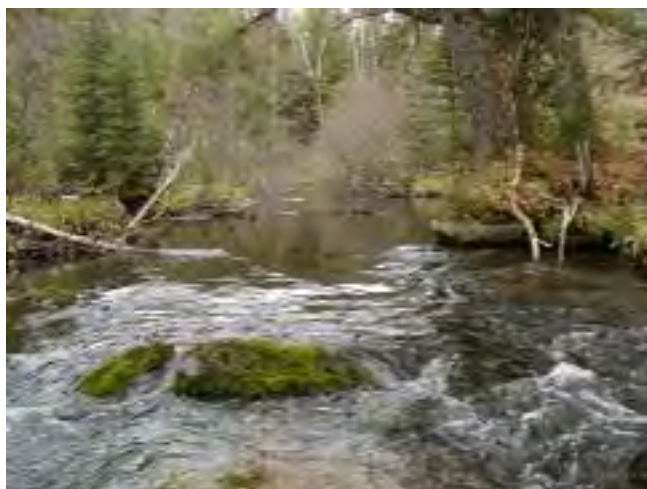
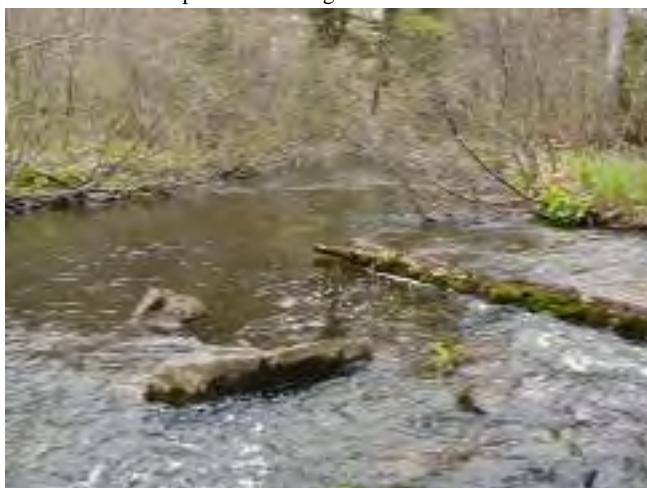
Salmon Trout River Monitoring, May 2005.
Site #10 East Branch Salmon Trout River

Downstream looking upstream

Upstream looking downstream

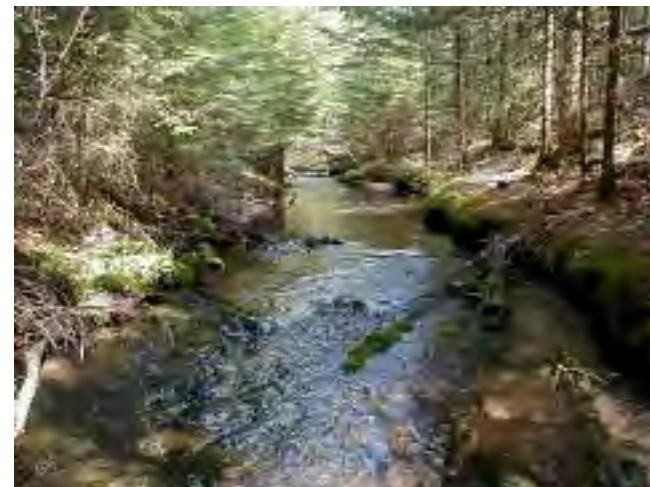
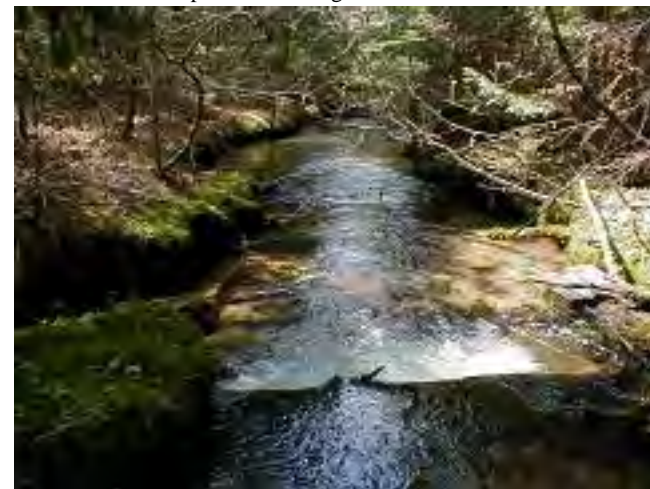
Salmon Trout River Monitoring, May 2005.
 Site #11 Clear Creek

Downstream looking upstream

Upstream looking downstream

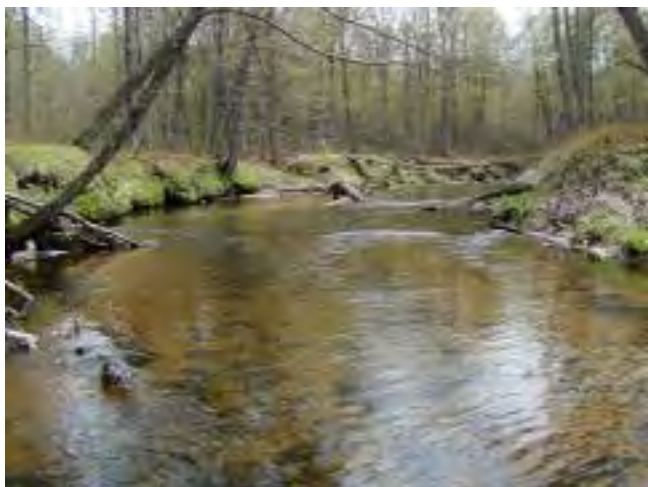
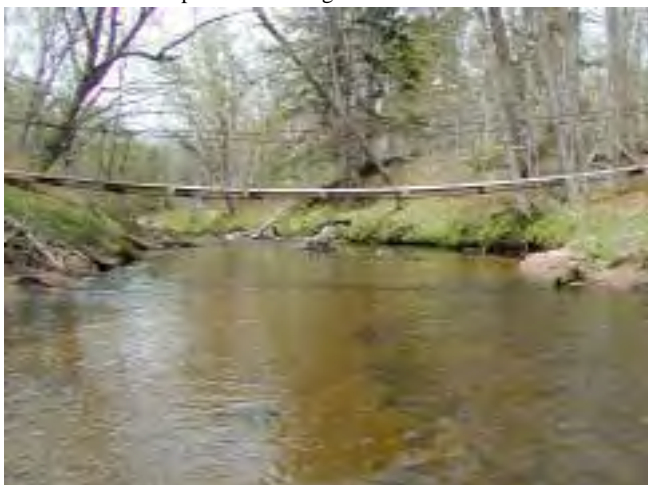
Salmon Trout River Monitoring, May 2005.
Site #12 Salmon Trout River

Downstream looking upstream

Upstream looking downstream

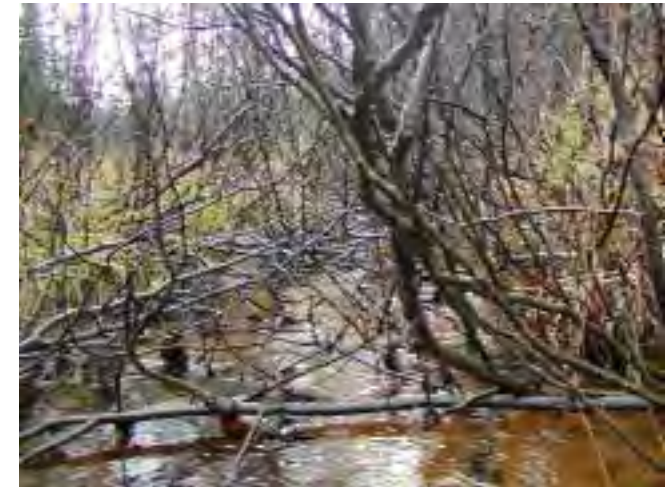
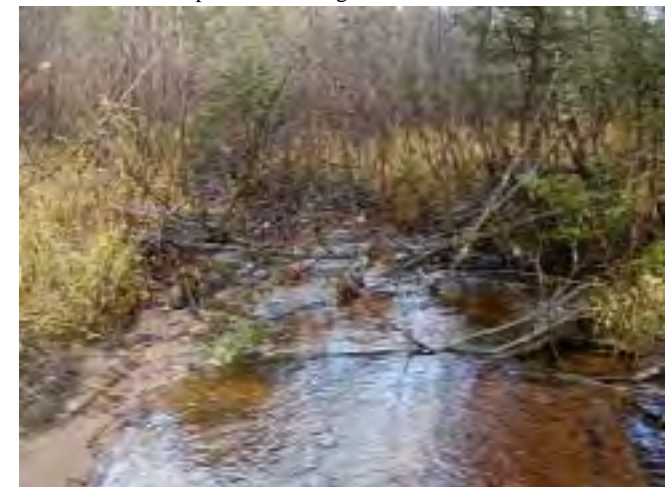
Salmon Trout River Monitoring, November 2005.
 Site #1 Main Branch Salmon Trout River

Downstream looking upstream

Upstream looking downstream

High sand deposition. Lots of aquatic plants. Some good gravel beds in scours. A pair of spawning brook trout were observed. There are some forestry flagging and foot trails in the area.

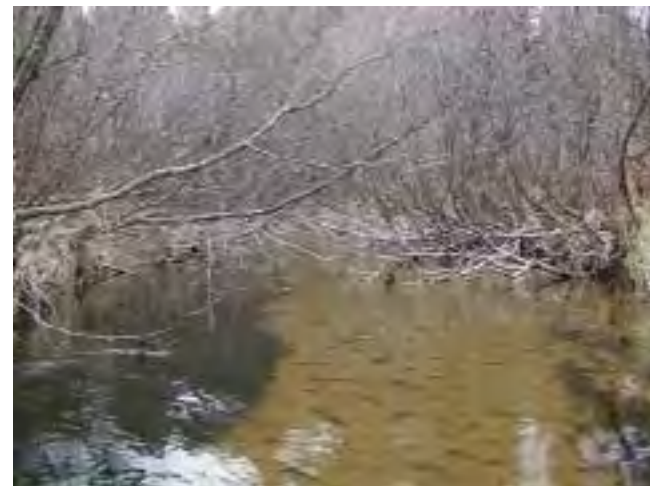
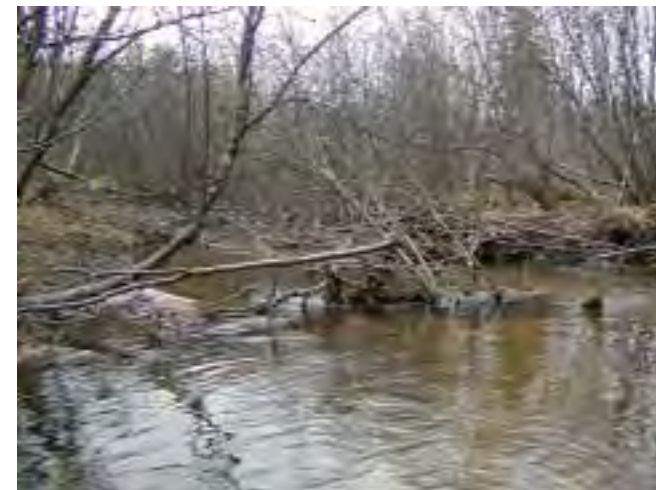
Salmon Trout River Monitoring, November 2005.
 Site #3 East Branch Salmon Trout River

Downstream looking upstream

Upstream looking downstream

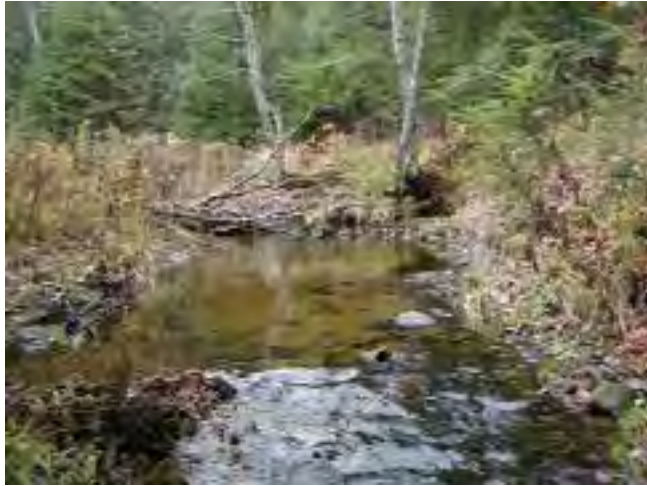
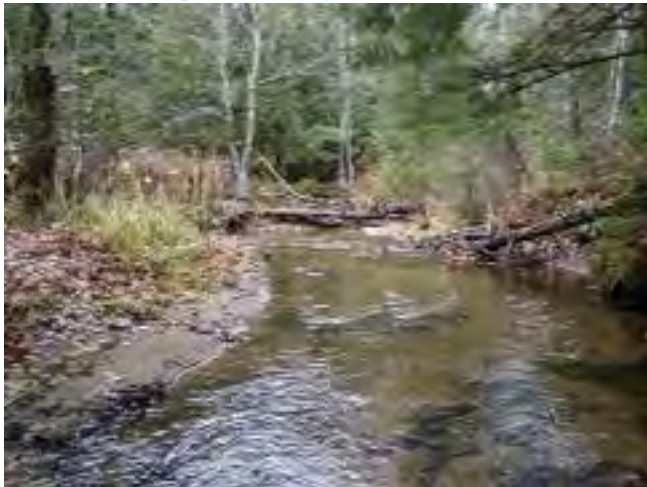
Salmon Trout River Monitoring, November 2005.
Site #4 Snake Creek

Downstream looking upstream

Upstream looking downstream

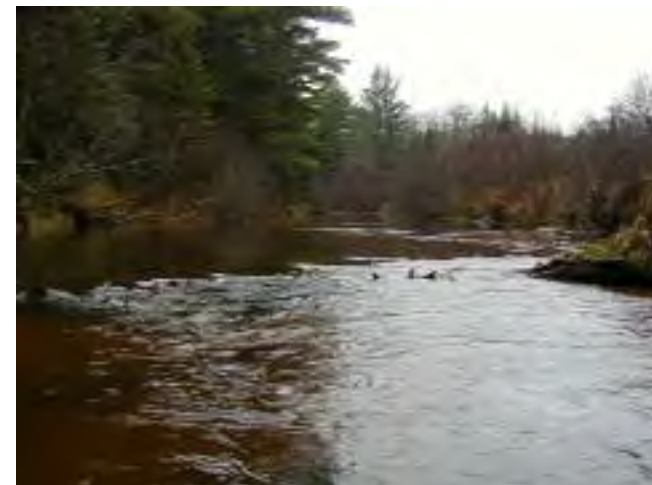
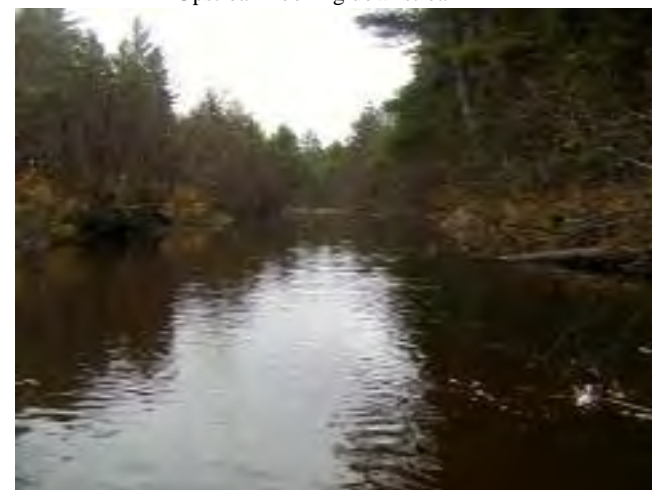
Salmon Trout River Monitoring, November 2005.
 Site #5 Salmon Trout River

Downstream looking upstream

Upstream looking downstream

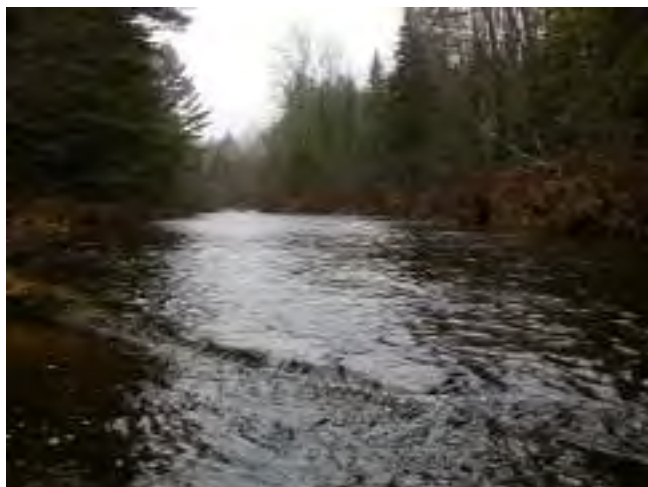
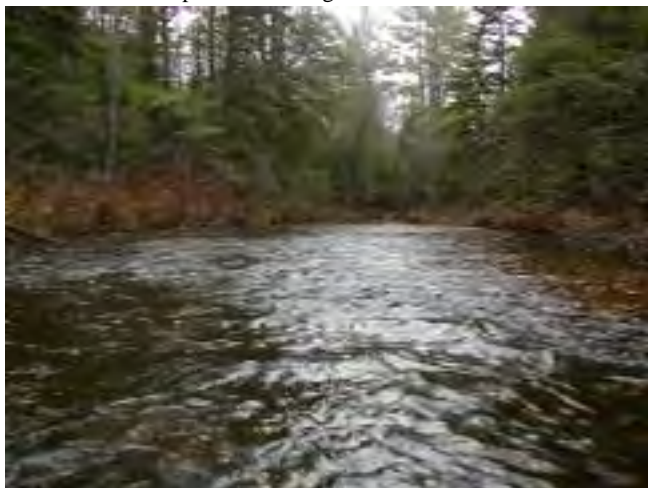
Salmon Trout River Monitoring, November 2005.
Site #6 Main Branch Salmon Trout River

Downstream looking upstream

Upstream looking downstream

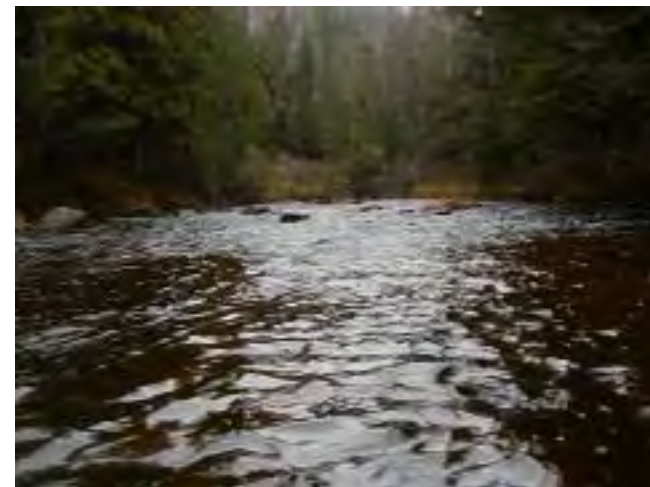
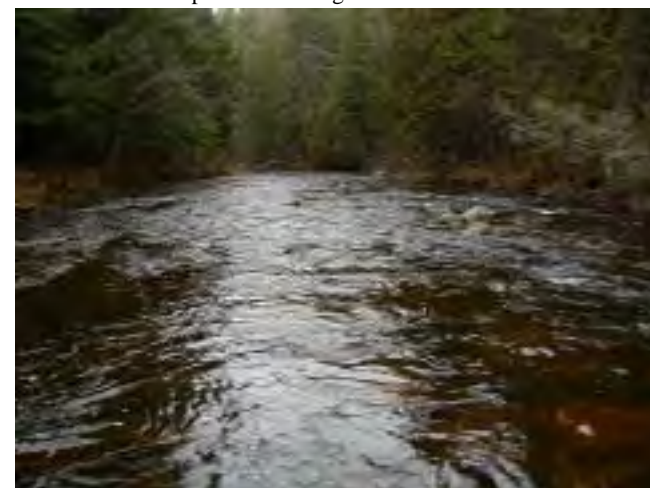
Salmon Trout River Monitoring, November 2005.
 Site #7 Main Branch Salmon Trout River

Downstream looking upstream

Upstream looking downstream

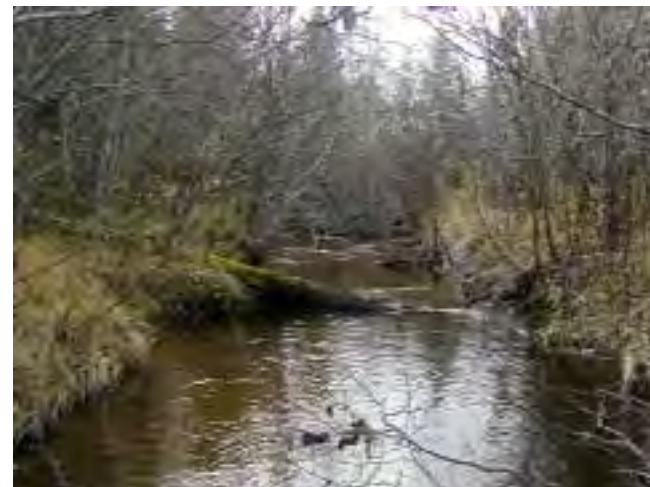
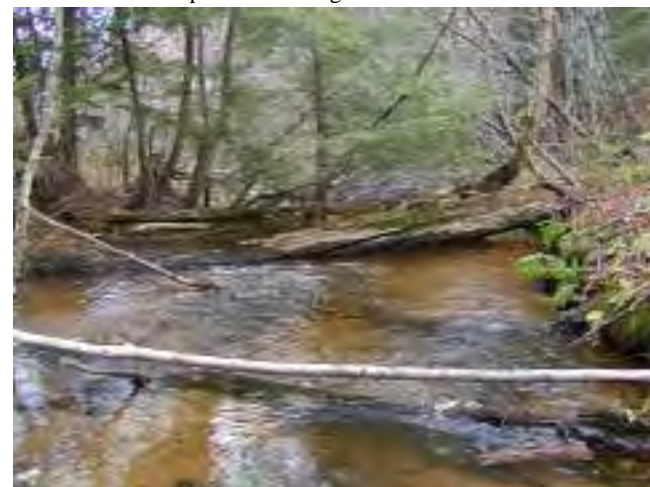
Salmon Trout River Monitoring, November 2005.
Site #8 Main Branch Salmon Trout River

Downstream looking upstream

Upstream looking downstream

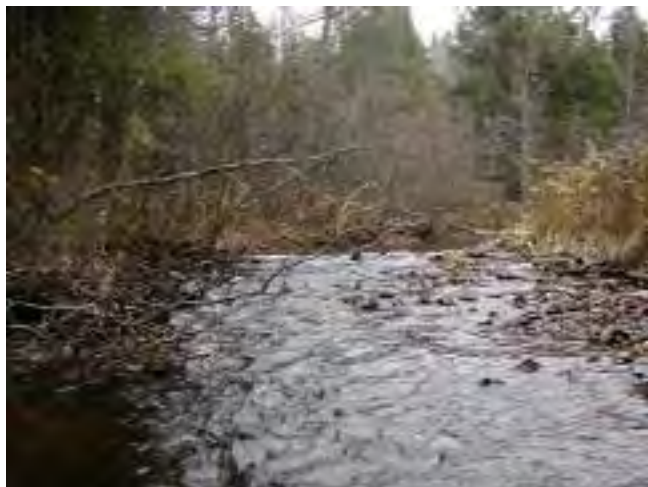
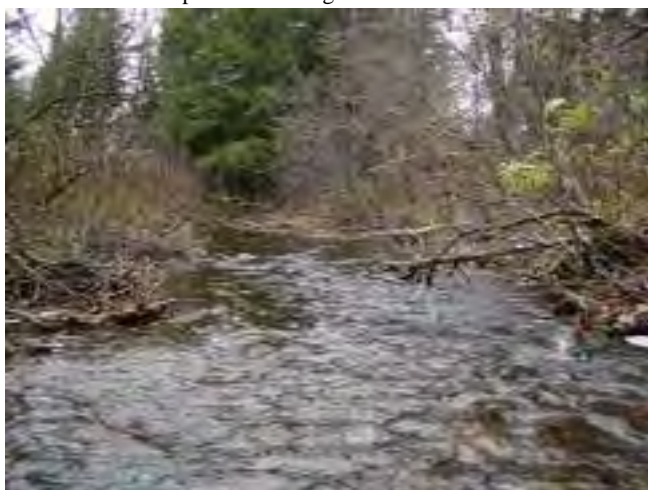
Salmon Trout River Monitoring, November 2005.
Site #9 Main Branch Salmon Trout River

Downstream looking upstream

Upstream looking downstream

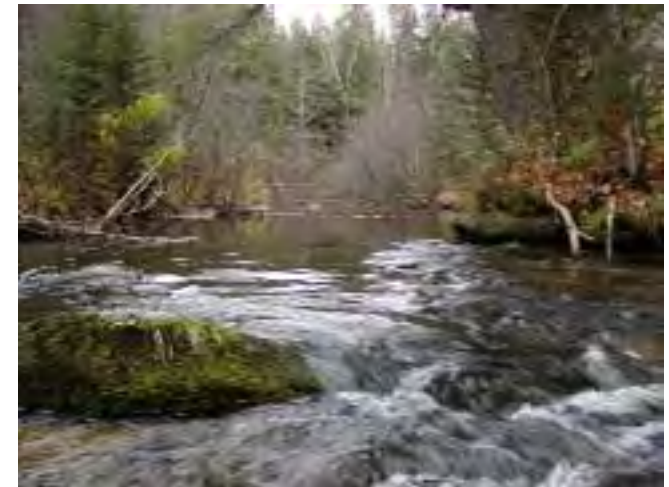
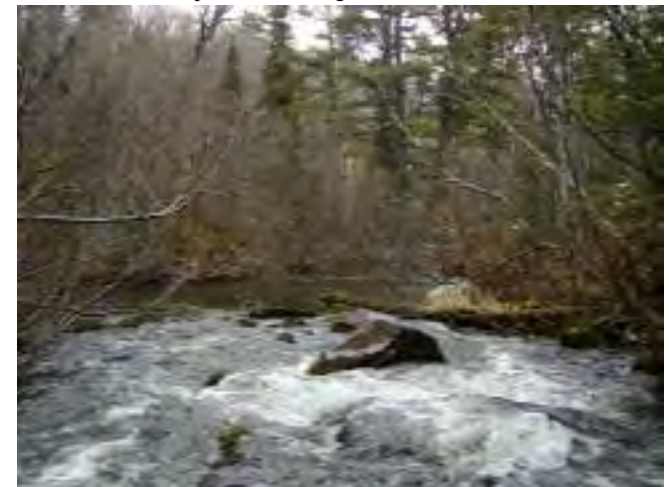
Salmon Trout River Monitoring, November 2005.
 Site #10 East Branch Salmon Trout River

Downstream looking upstream

Upstream looking downstream

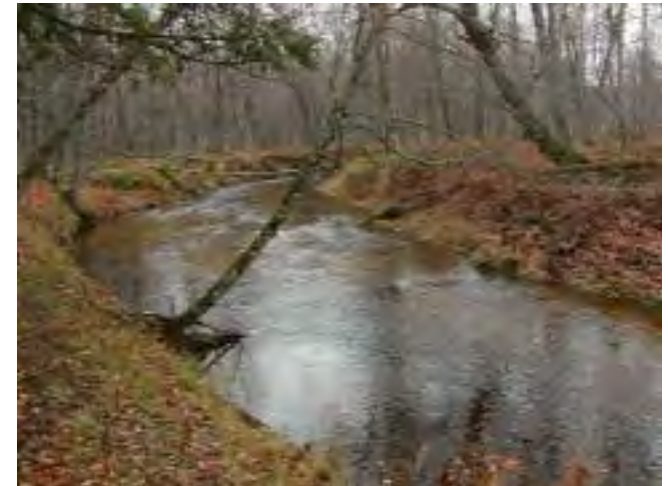
Salmon Trout River Monitoring, November 2005.
 Site #12 Salmon Trout River

Downstream looking upstream

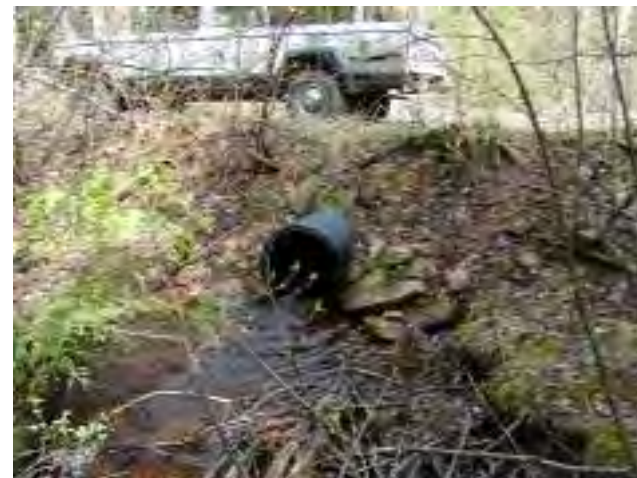
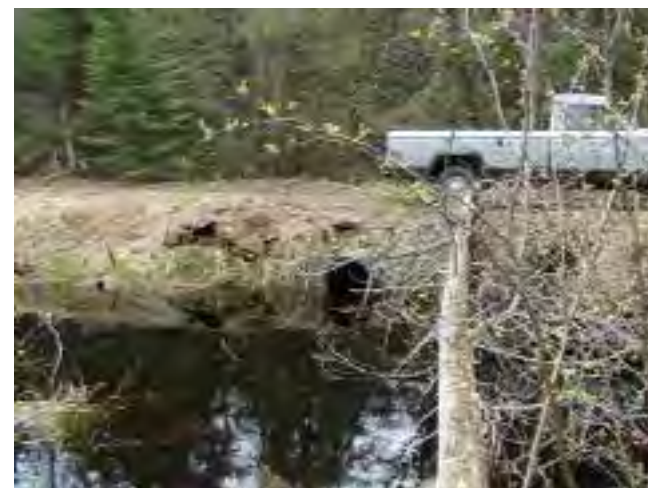
Salmon Trout River Watershed Road Crossing Inventory, Summer 2006 Crossing #1 Conway Creek @ Private Road T 52 N R 28 W Sec. 36 SW 1/4 of NE 1/4

Downstream Looking up

Upstream Looking Down

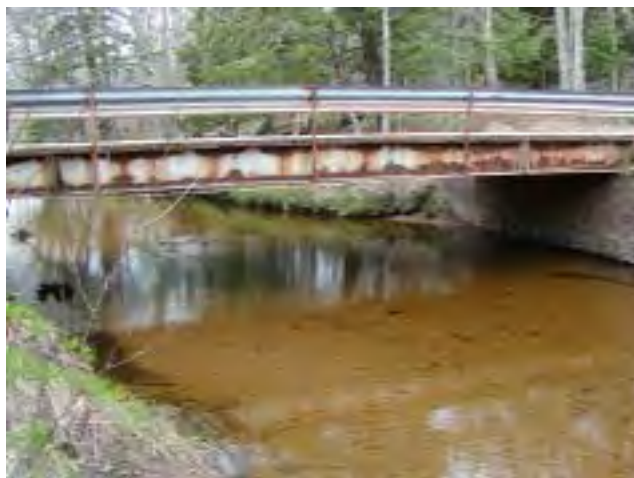
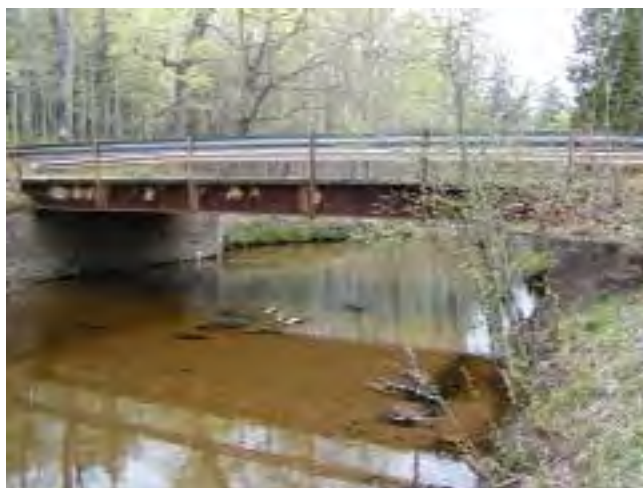
Salmon Trout River Watershed
Road Crossing Inventory, Summer 2006
Crossing #2 Salmon Trout River @ County Rd K
T 51 N R 28 W Sec. 1 NW 1/4 of NE 1/4

Downstream Looking up

Upstream Looking Down

Newer Culvert installed by the County Road Commission in 2001

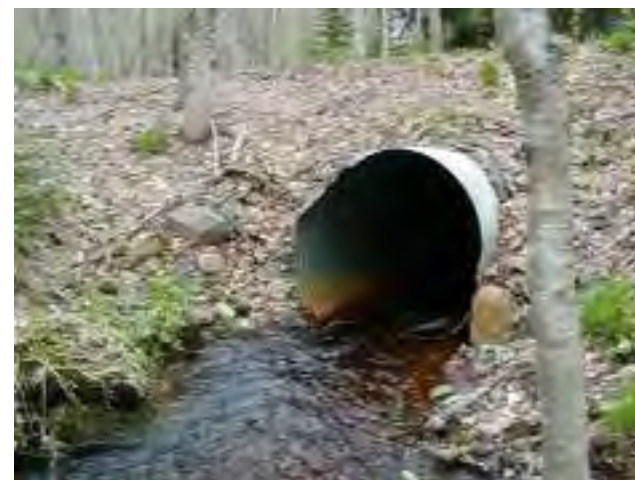
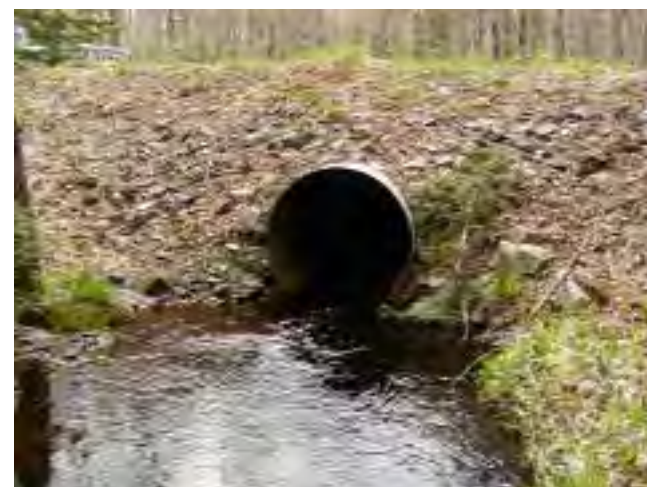
Salmon Trout River Watershed Road Crossing Inventory, Summer 2006 Crossing #3 Sullivan Creek @ County Road KI T 51 N R 27 W Sec. 6 SW 1/4 of SE 1/4

Downstream Looking up

Upstream Looking Down

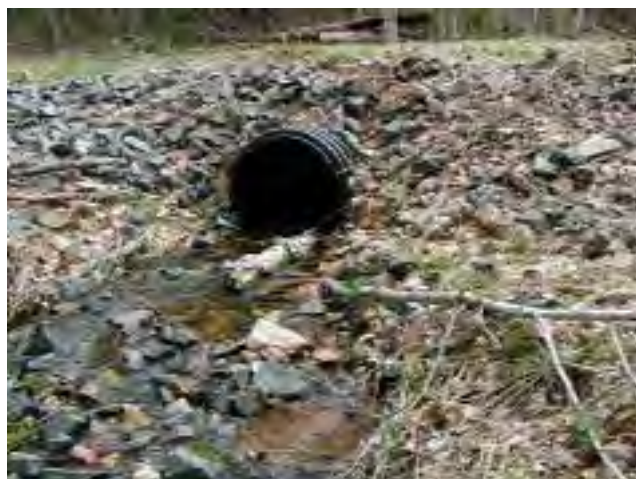
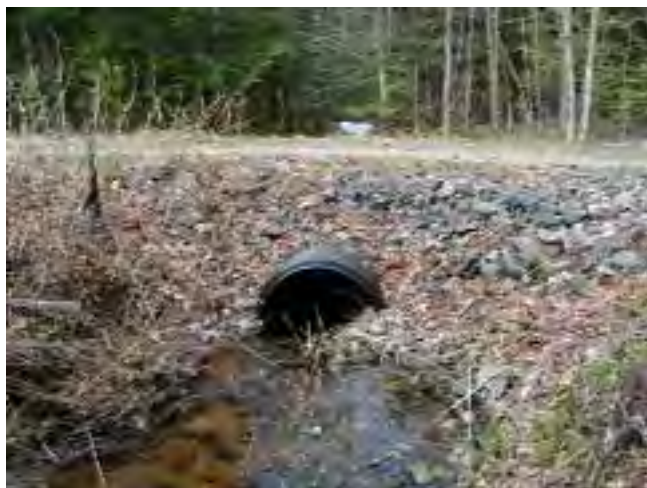
Salmon Trout River Watershed
Road Crossing Inventory, Summer 2006
Crossing #4 Murphy's Creek @ Two Track
(Pine Mt. Road)
T 51 N R 27 W Sec. 7 SW 1/4 of NW 1/4

Downstream Looking up

Upstream Looking Down

This crossing is shown on most maps, but no stream channel is present. Culvert is completely buried.

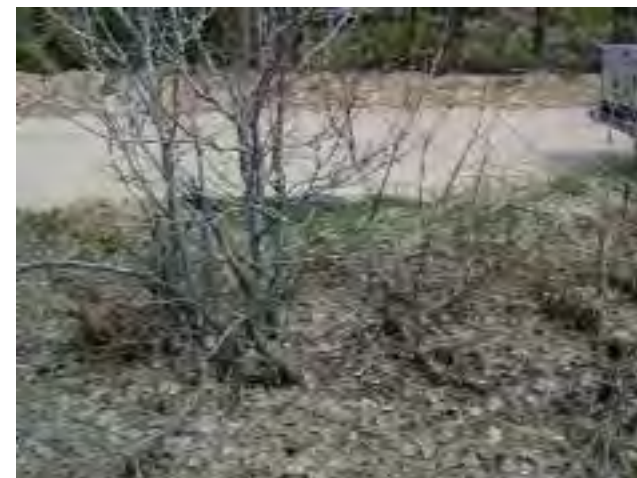
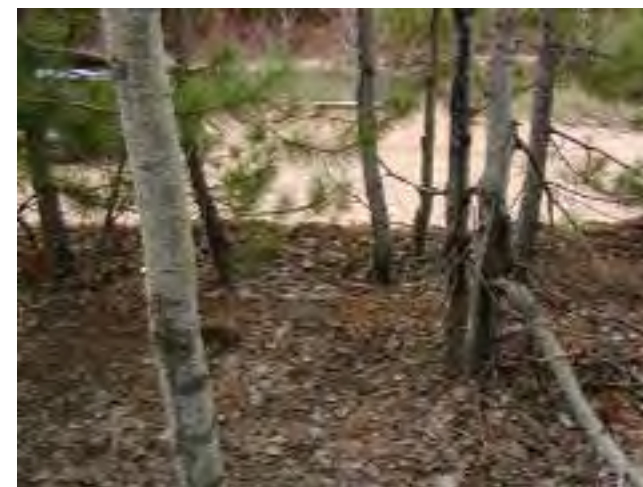
Salmon Trout River Watershed Road Crossing Inventory, Summer 2006 Crossing #5 Clear Creek @ Blind 35 (1) T 51 N R 27 W Sec. 30 SE 1/4 of NE 1/4

Downstream Looking up

Upstream Looking Down

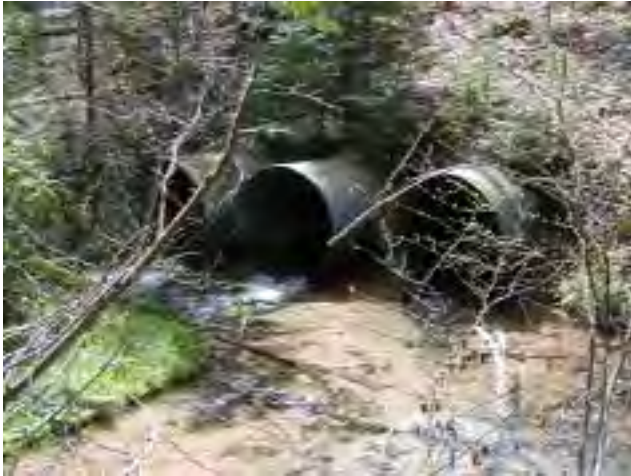
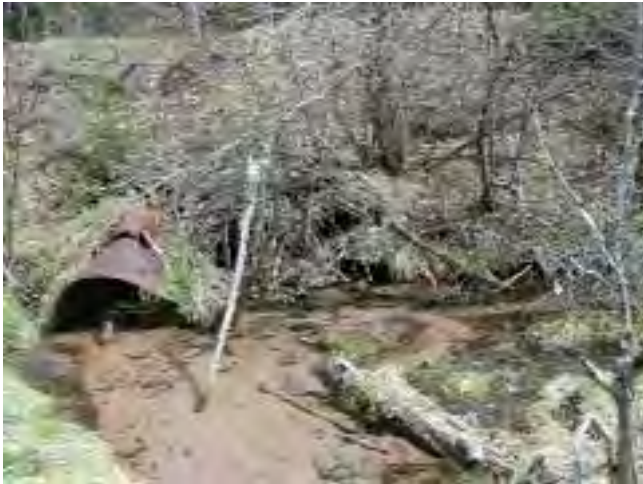
Salmon Trout River Watershed
Road Crossing Inventory, Summer 2006
Crossing #6 Clear Creek @ Blind 35 (2)
T 51 N R 27 W Sec. 19 NE 1/4 of SW 1/4

Downstream Looking up

Upstream Looking Down

This crossings seems to be used by ATV and foot traffic only, but is definitely being used. Fresh ATV tracks where seen

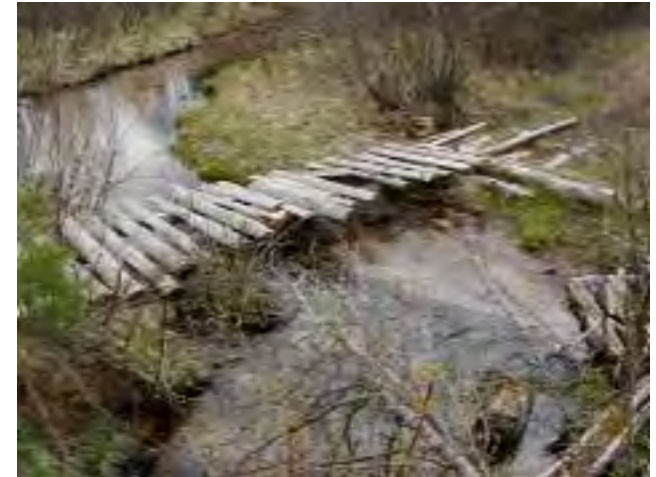
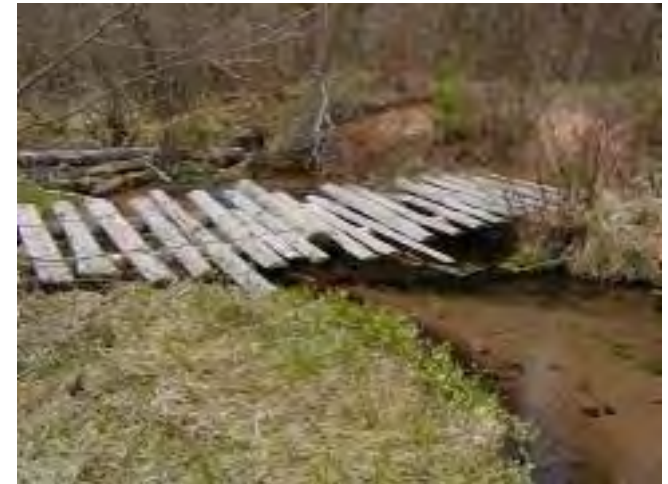
Salmon Trout River Watershed Road Crossing Inventory, Summer 2006 Crossing #7 Clear Creek @ unnamed two track trail T 51 N R 27 W Sec. 19 NE 1/4 of SW 1/4

Downstream Looking up

Upstream Looking Down

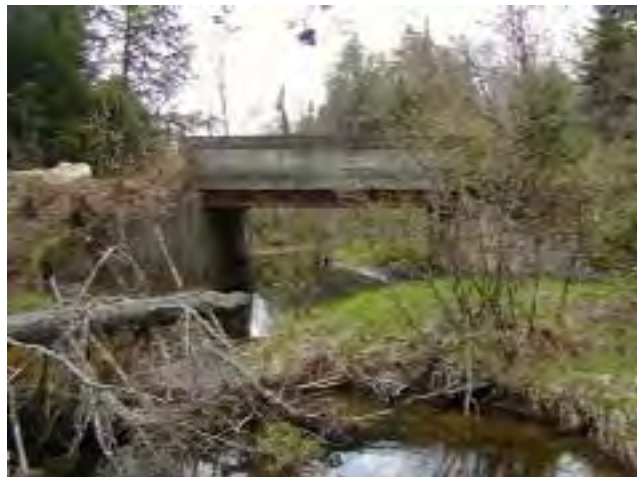
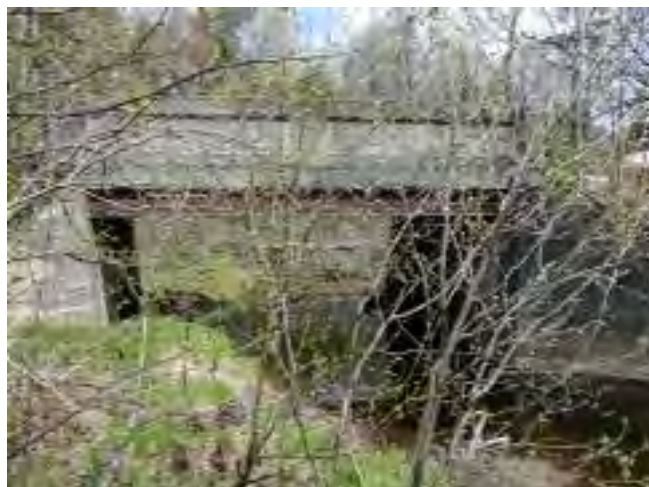
Salmon Trout River Watershed
Road Crossing Inventory, Summer 2006
Crossing #8 Snake Creek @ Blind 35
T 51 N R 28 W Sec. 23 NW 1/4 of NE 1/4

Downstream Looking up

Upstream Looking Down

Historic ATV ford, there was a temporary bridge for logging equipment installed in 2004 and removed in 2005, leaving behind lots of boulder/rip rap armoring and well armored approach ditches

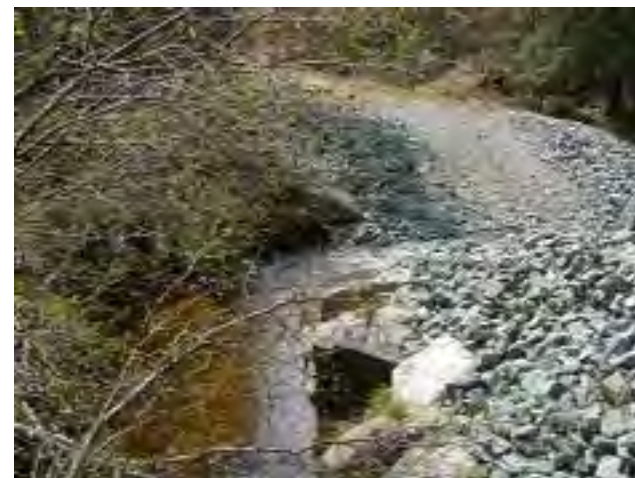
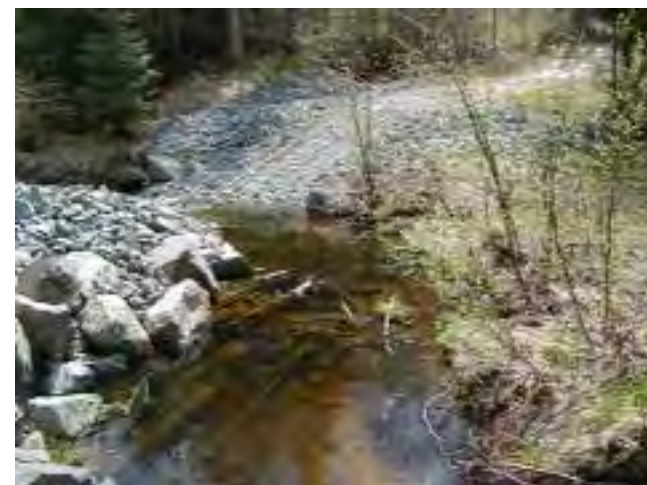
Salmon Trout River Watershed Road Crossing Inventory, Summer 2006 Crossing #9 Snake Creek @ Unnamed two track T 51 N R 28 W Sec. 23 NE 1/4 of SW 1/4

Downstream Looking up

Upstream Looking Down
