Salmon Trout River

WATERSHED MANAGEMENT PLAN

**Water Quality Protection, Habitat Restoration
and Pollution Prevention**

July 2007

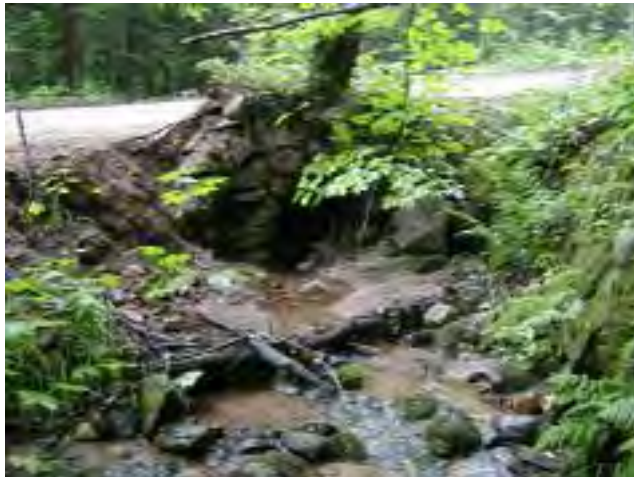
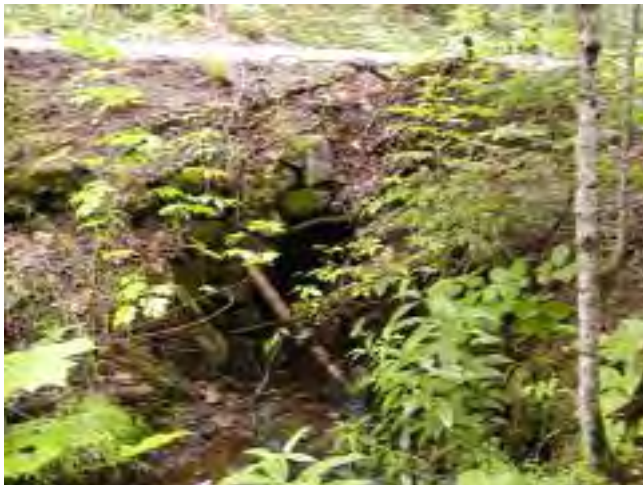
Salmon Trout River Watershed
Road Crossing Inventory, Summer 2005
Crossing #10 East Branch @ Triple A Road (1)
T 50 N R 28 W Sec. 3 SW 1/4 of SW 1/4

Downstream Looking up

Upstream Looking Down

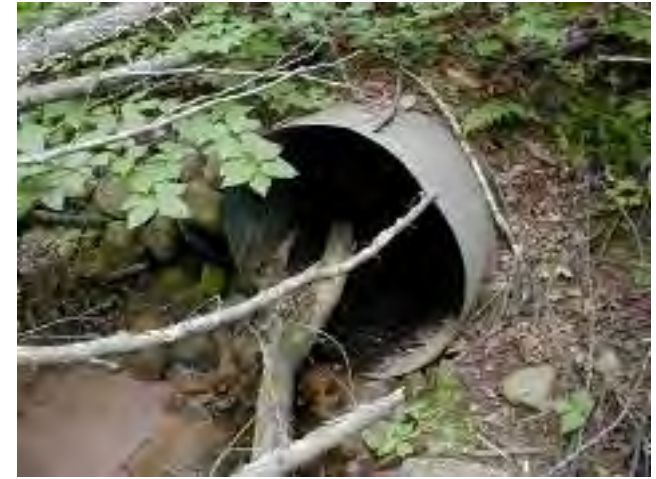
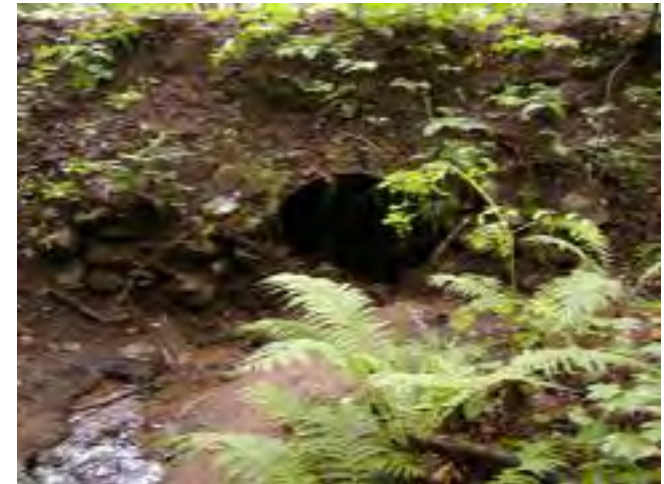
Salmon Trout River Watershed Road Crossing Inventory, Summer 2005 Crossing #11 East Branch @ Triple A Road (2) T 50 N R 28 W Sec. 3 SW 1/4 of SW 1/4

Downstream Looking up

Upstream Looking Down

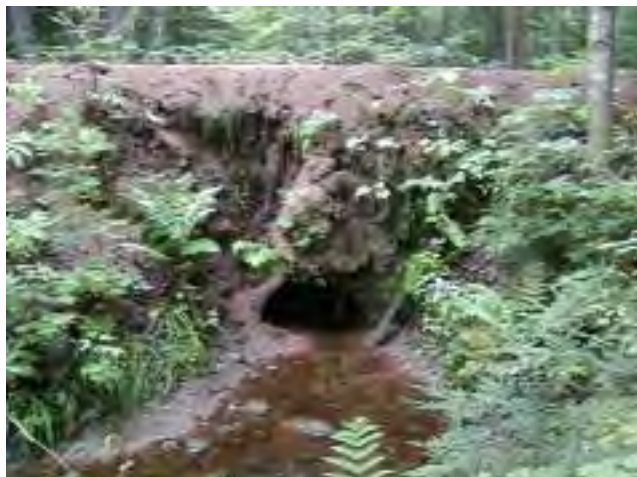
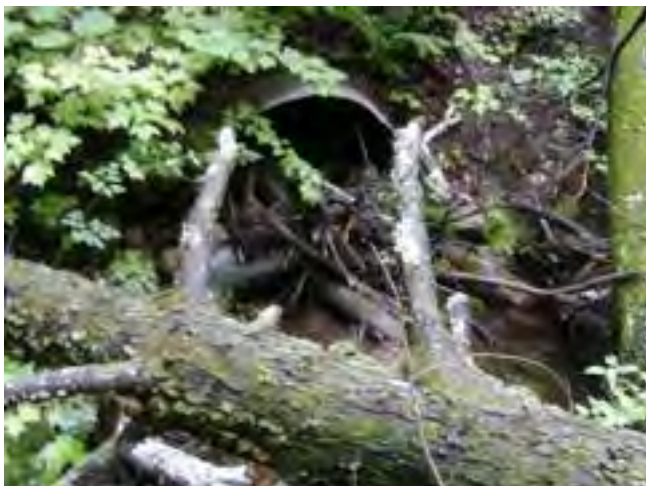
Salmon Trout River Watershed
Road Crossing Inventory, Summer 2005
Crossing #12 East Branch @ Triple A Road (3)
T 50 N R 28 W Sec. 4 SE 1/4 of SE 1/4

Downstream Looking up

Upstream Looking Down

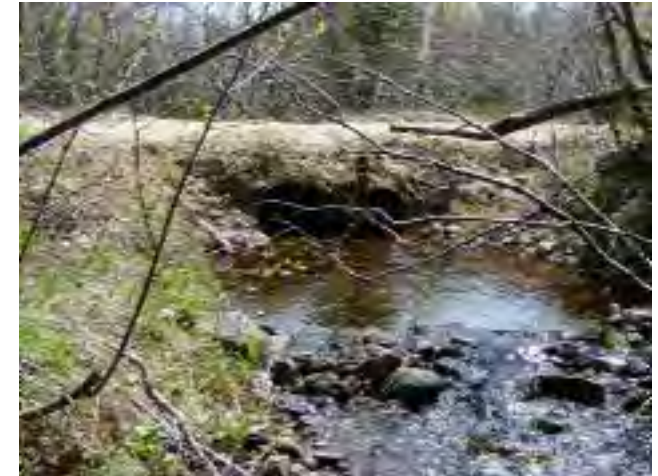
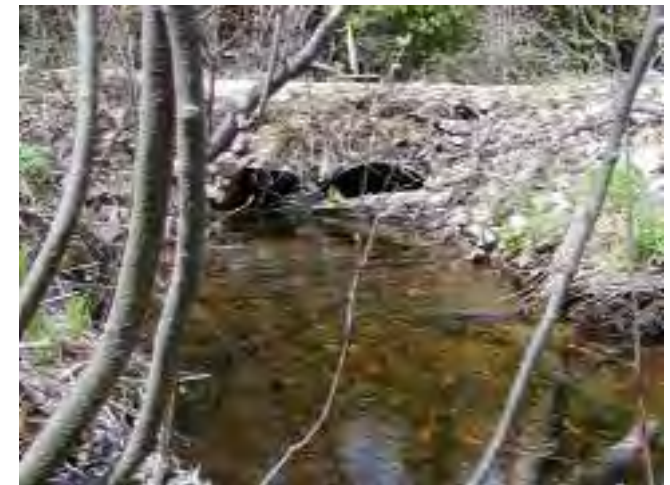
Salmon Trout River Watershed Road Crossing Inventory, Summer 2006 Crossing #13 East Branch @ Northwestern Road T 50 N R 28 W Sec. 4 NW 1/4 of SW 1/4

Downstream Looking up

Upstream Looking Down

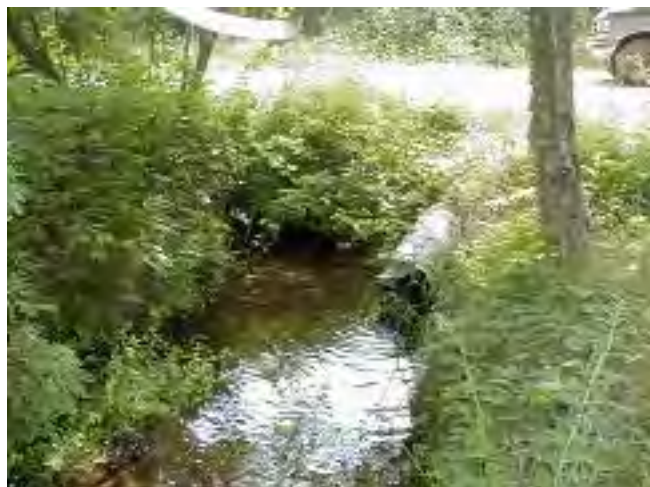
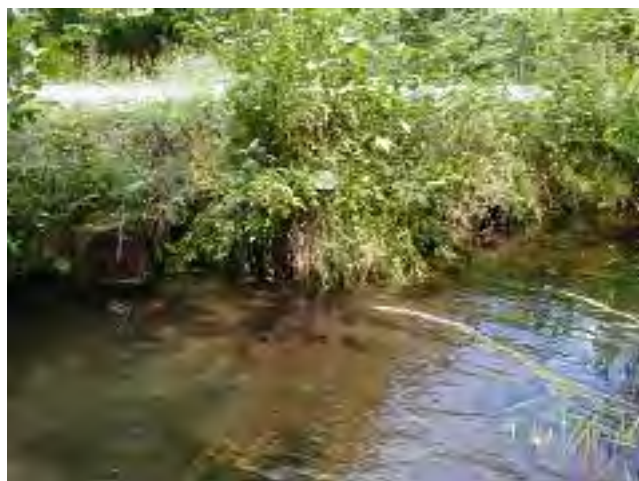
Salmon Trout River Watershed
Road Crossing Inventory, Summer 2005
Crossing #14 Tributary to East Branch
@ Northwestern Road
T 50 N R 28 W Sec. 4 NW 1/4 of SW 1/4

Downstream Looking up

Upstream Looking Down

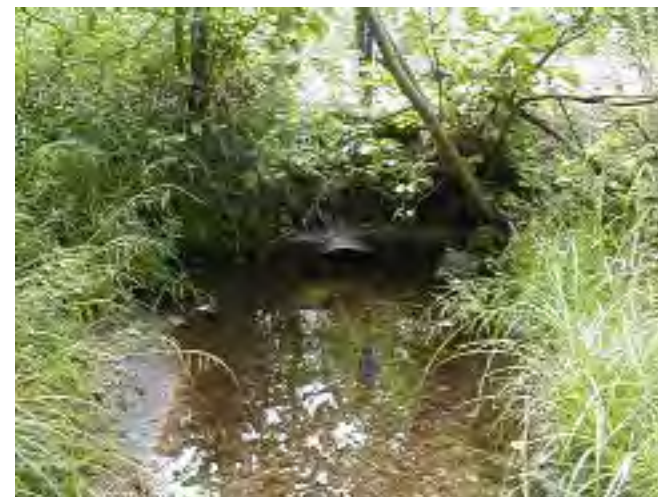
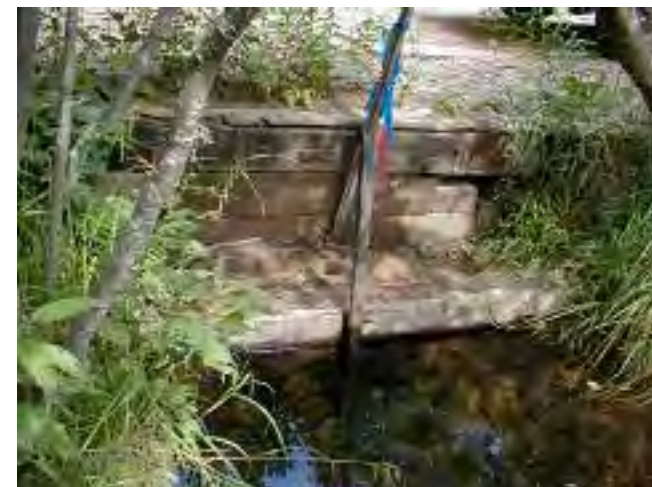
Salmon Trout River Watershed
Road Crossing Inventory, Summer 2005
Crossing #15 Tributary to East Branch
@ Northwestern Road
T 50 N R 28 W Sec. 5 NE 1/4 of SE 1/4

Downstream Looking up
Upstream Looking Down

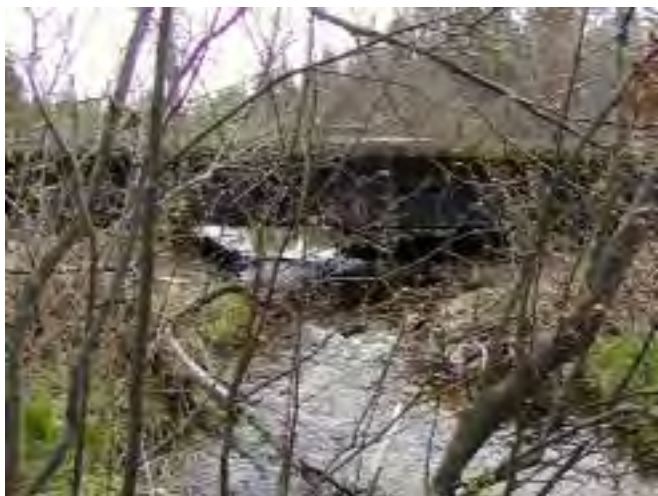
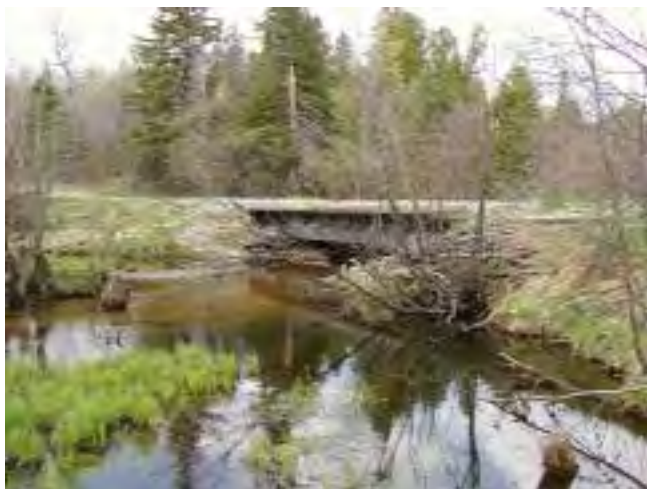
Salmon Trout River Watershed
Road Crossing Inventory, Summer 2005
Crossing #16 Tributary to East Branch
@ Northwestern Road
T 50 N R 28 W Sec. 5 SW 1/4 of NE 1/4

Downstream Looking up

Upstream Looking Down

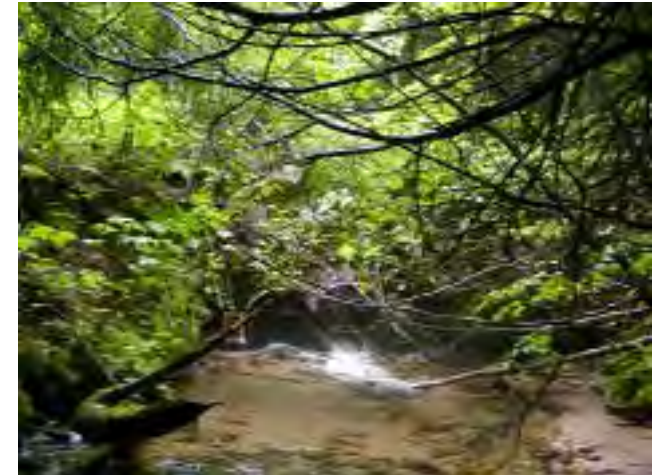
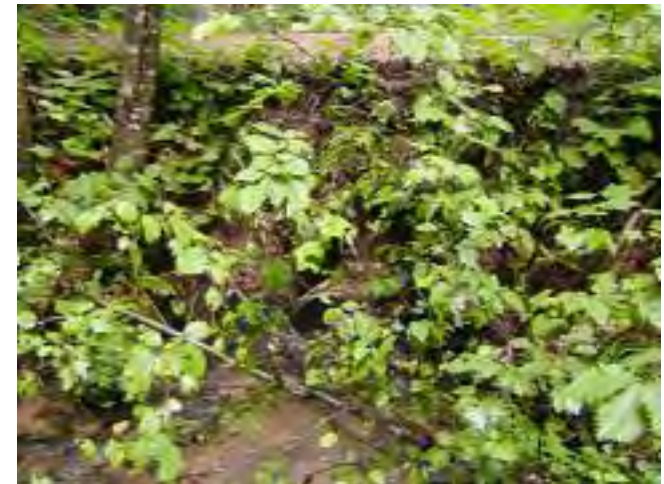
Salmon Trout River Watershed
Road Crossing Inventory, Summer 2005
Crossing #17 Tributary to East Branch
@ Unnamed Road
T 50 N R 28 W Sec. 6 SE 1/4 of NE 1/4

Downstream Looking up

Upstream Looking Down

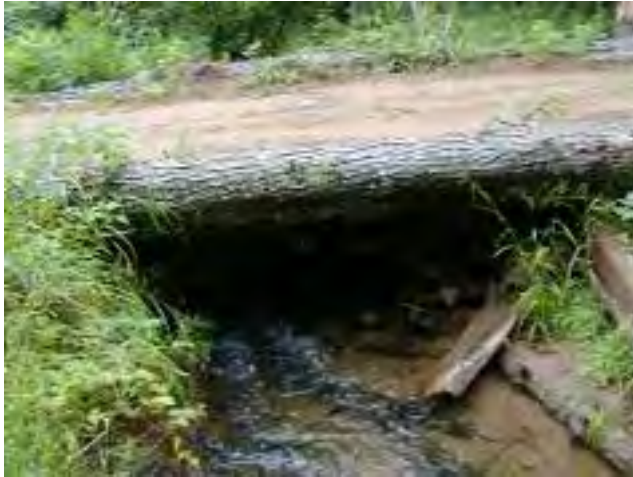
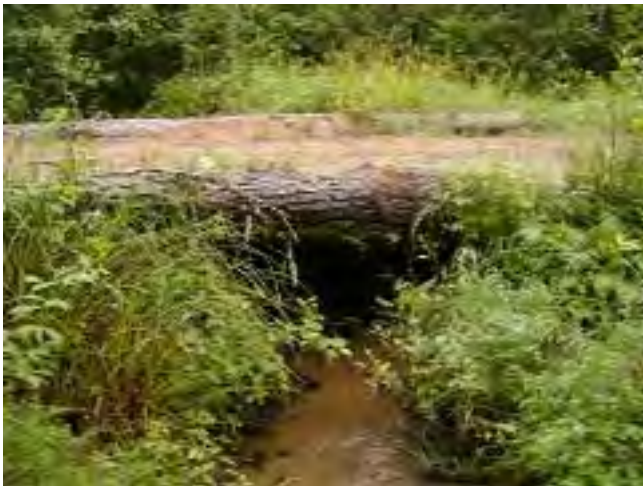
Salmon Trout River Watershed
Road Crossing Inventory, Summer 2005
Crossing #18 Tributary to East Branch
@ Unnamed road
T 50 N R 28 W Sec. 6 NE 1/4 of NE 1/4

Downstream Looking up

Upstream Looking Down

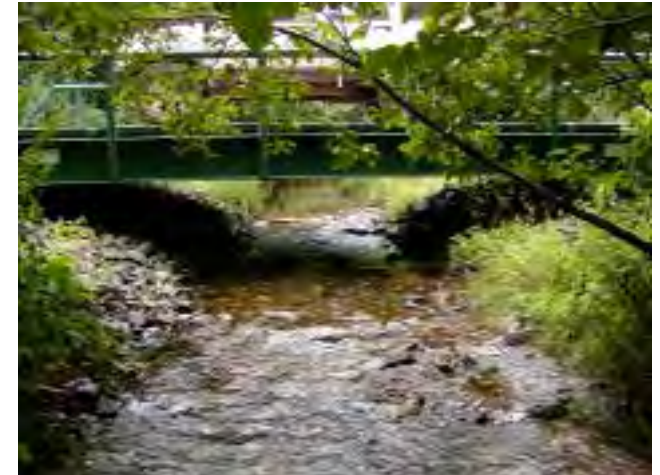
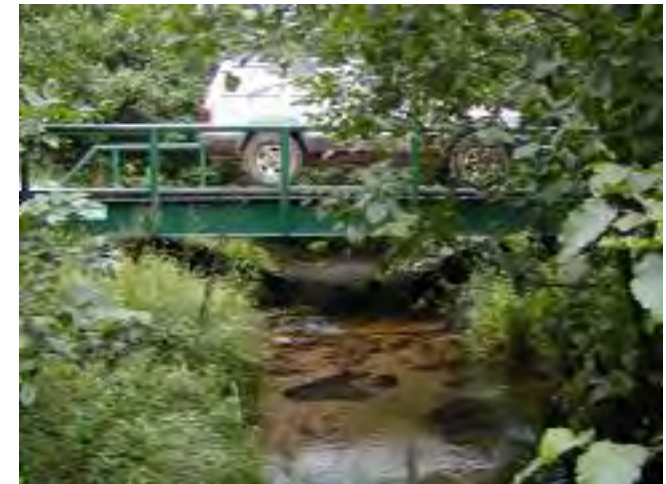
Salmon Trout River Watershed
Road Crossing Inventory, Summer 2005
Crossing #19 Tributary to East Branch
@ Northwestern Road
T 51 N R 28 W Sec. 34 SW 1/4 of SE 1/4

Downstream Looking up

Upstream Looking Down

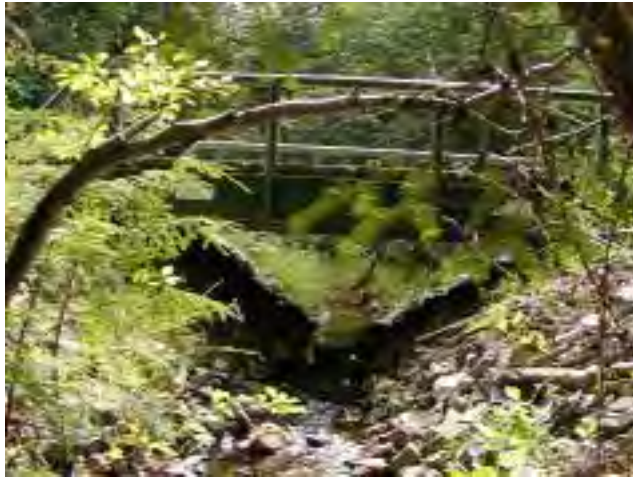
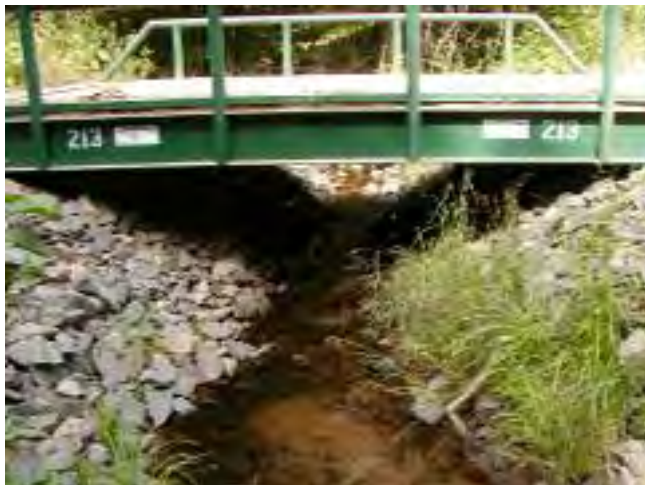
Salmon Trout River Watershed
Road Crossing Inventory, Summer 2005
Crossing #20 Tributary to East Branch
@ Northwestern Road
T 51 N R 28 W Sec. 33 SE 1/4 of NW 1/4

Downstream Looking up

Upstream Looking Down

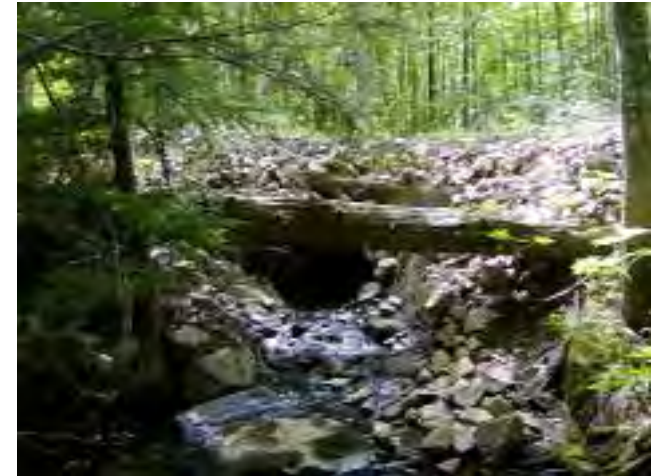
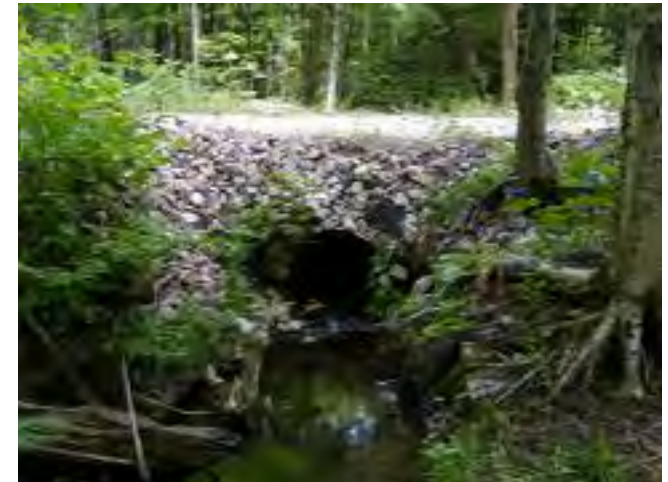
Salmon Trout River Watershed
Road Crossing Inventory, Summer 2005
Crossing #21 Tributary to Main Branch
@ Northwestern Road
T 51 N R 28 W Sec. 28 SW 1/4 of SW 1/4

Downstream Looking up

Upstream Looking Down

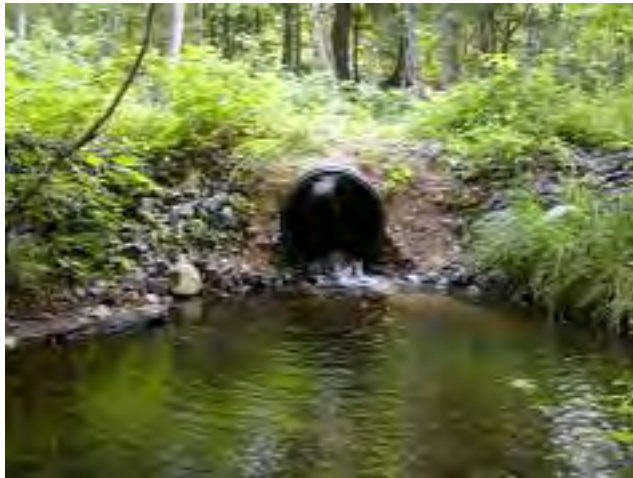
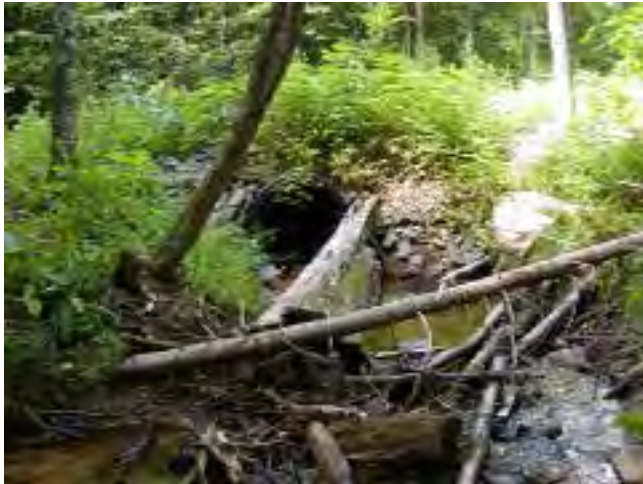
Salmon Trout River Watershed
Road Crossing Inventory, Summer 2005
Crossing #22 Tributary to Main Branch
@ Unnamed two track
T 51 N R 28 W Sec. 28 SW 1/4 of SW 1/4

Downstream Looking up

Upstream Looking Down

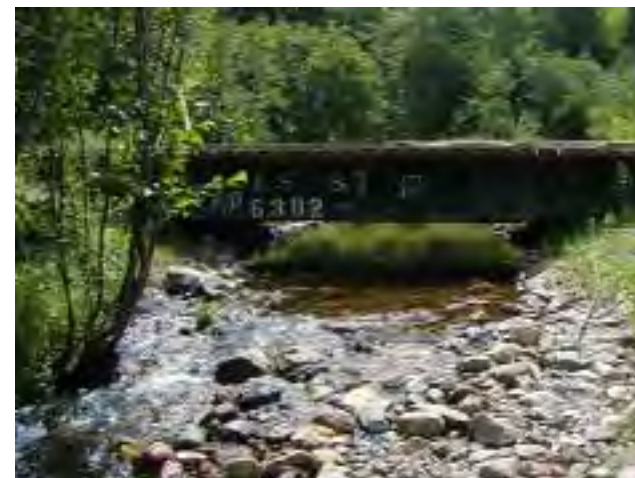
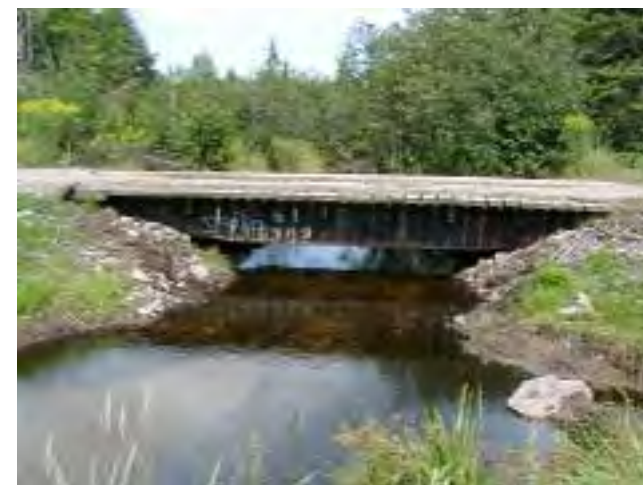
Salmon Trout River Watershed Road Crossing Inventory, Summer 2005 Crossing #23 Salmon Trout River @ Northwestern Road T 51 N R 28 W Sec. 29 SE 1/4 of SE 1/4

Comments: Bridge installed in 2001, replaced a very old four culvert system. USGS gauge immediately downstream.

Downstream Looking up

Upstream Looking Down

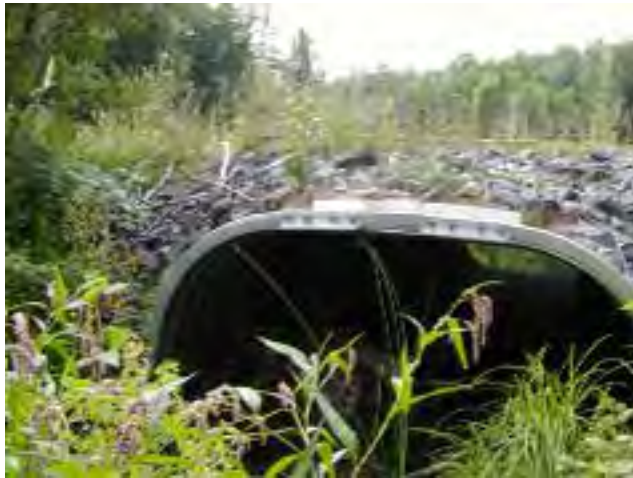
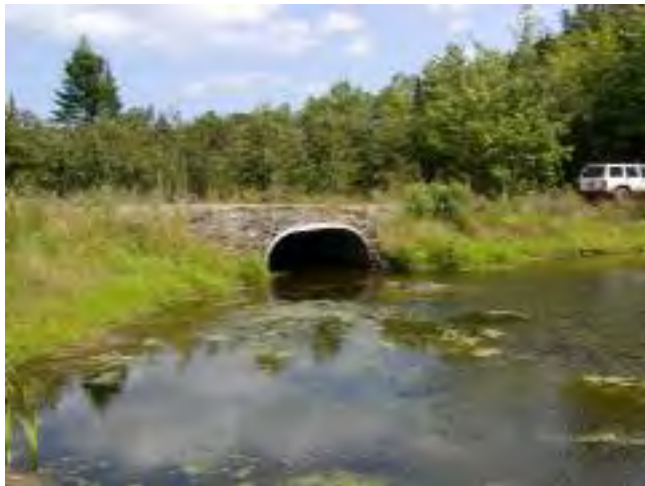
Salmon Trout River Watershed
Road Crossing Inventory, Summer 2005
Crossing #24 Tributary to West Branch
@ Northwestern Road
T 51 N R 28 W Sec. 29 NW 1/4 of SE 1/4

Downstream Looking up

Upstream Looking Down

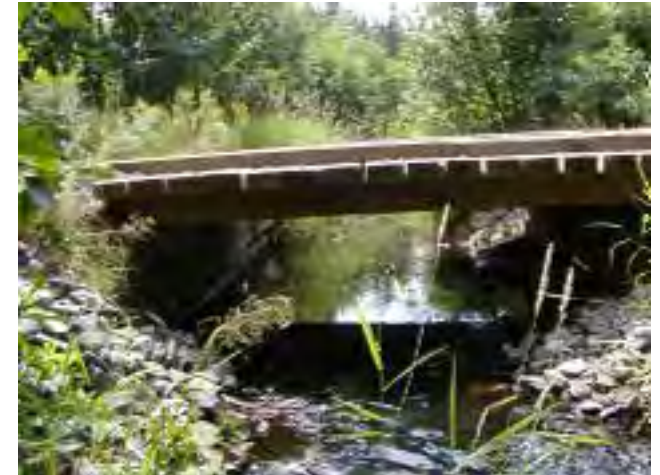
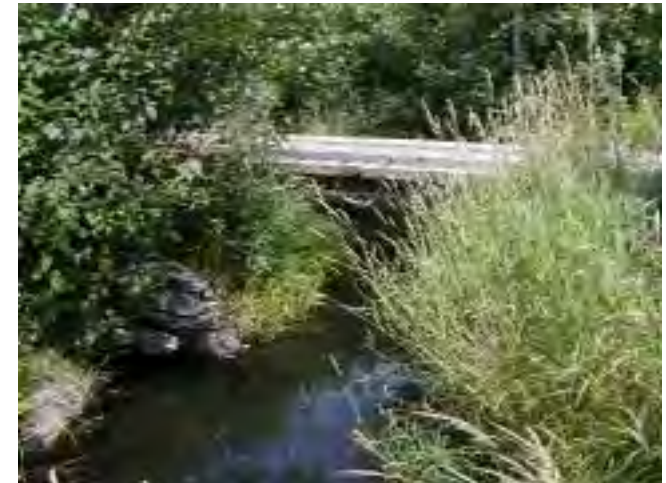
Salmon Trout River Watershed Road Crossing Inventory, Summer 2005 Crossing #25 West Branch @ Northwestern Road T 51 N R 28 W Sec. 29 SW 1/4 of NE 1/4

- Sturdy timber bridge, with timber abutments.

Downstream Looking up

Upstream Looking Down

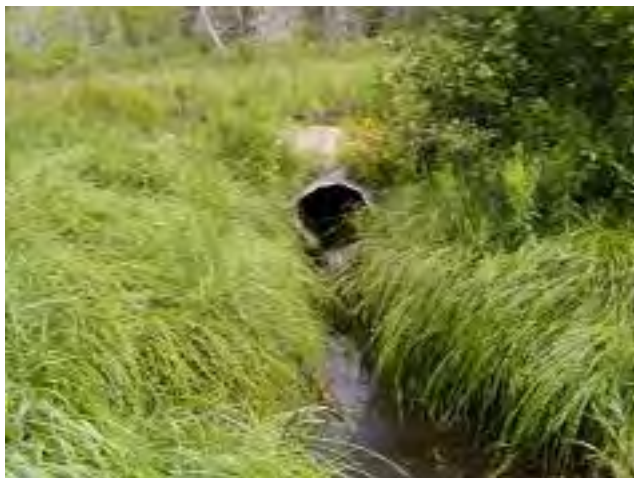
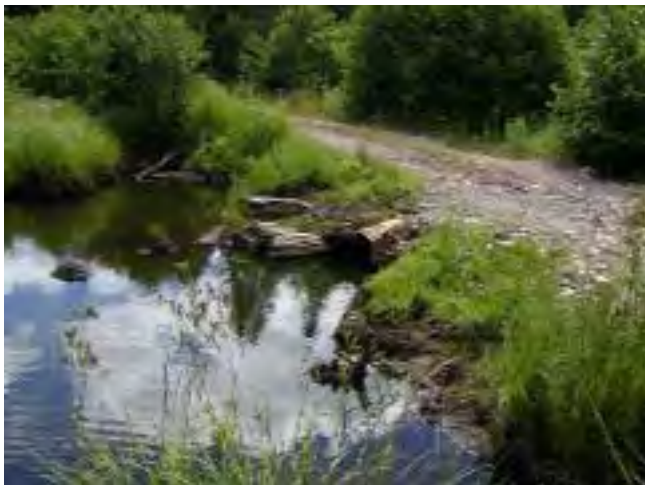
Salmon Trout River Watershed
Road Crossing Inventory, Summer 2005
Crossing #26 Iron Creek @ Unnamed two track
T 51 N R 28 W Sec. 29 SE 1/4 of NW 1/4

Downstream Looking up

Upstream Looking Down

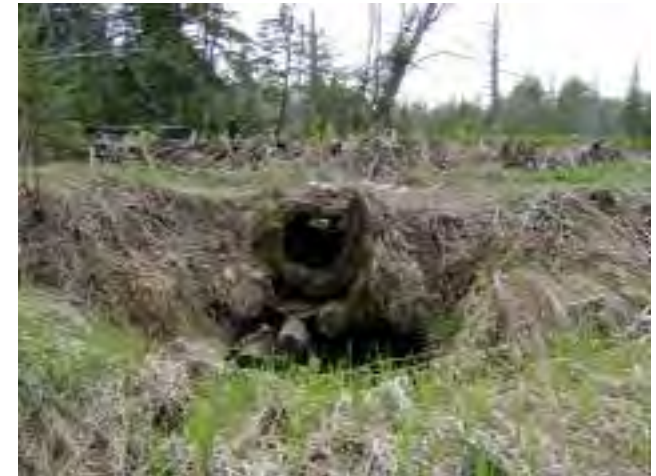
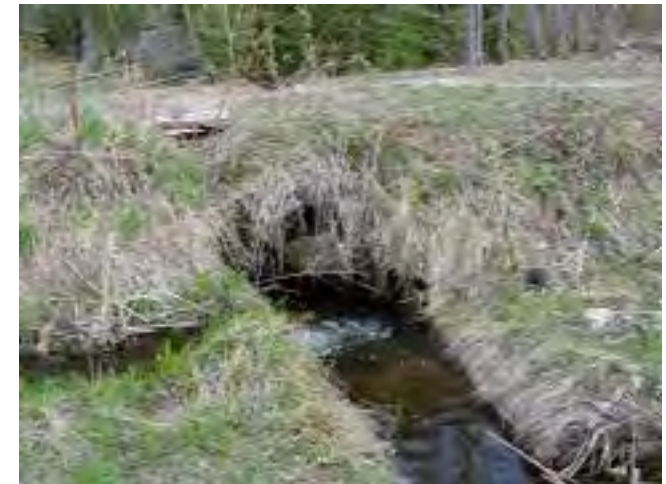
Salmon Trout River Watershed
Road Crossing Inventory, Summer 2005
Crossing #27 Tributary to Main Branch
@ Unnamed two track
T 51 N R 28 W Sec. 32 NE 1/4 of SW 1/4

- Hollw log used as a culvert in an old logging trail. Water has undermined the log and flows under it. Very large beaver pond upstream and down of this road.

Downstream Looking up

Upstream Looking Down

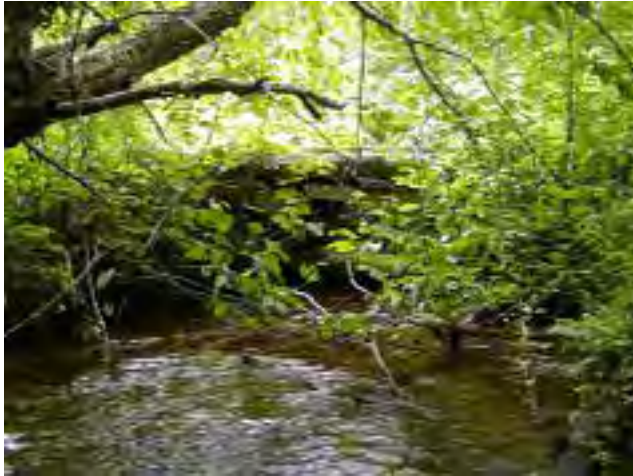
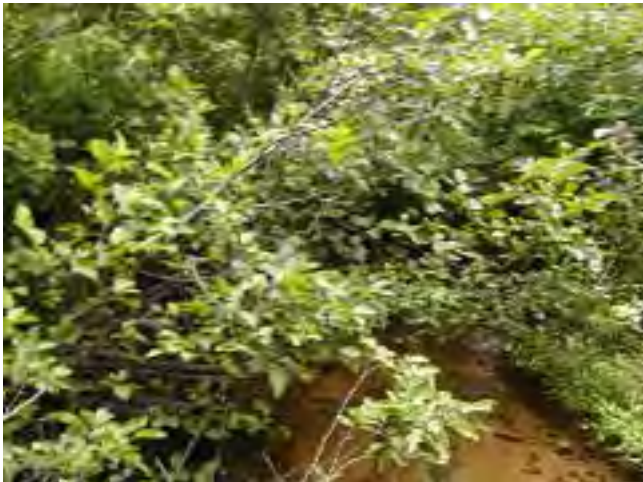
Salmon Trout River Watershed
Road Crossing Inventory, Summer 2005
Crossing #28 Salmon Trout River
@ Unnamed two track
T 51 N R 28 W Sec. 32 SE 1/4 of NW 1/4

Downstream Looking up

Upstream Looking Down

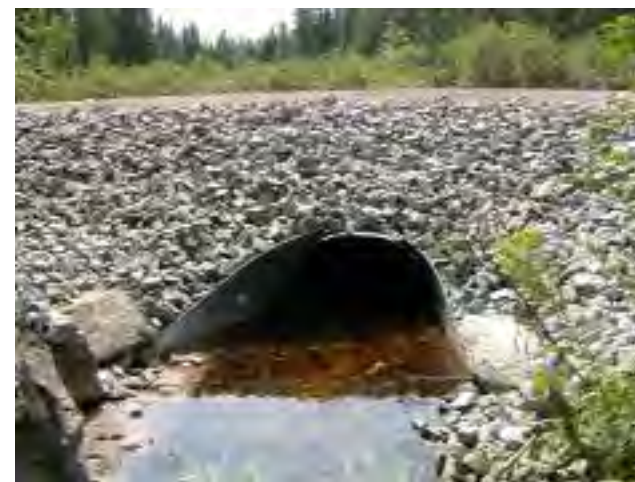
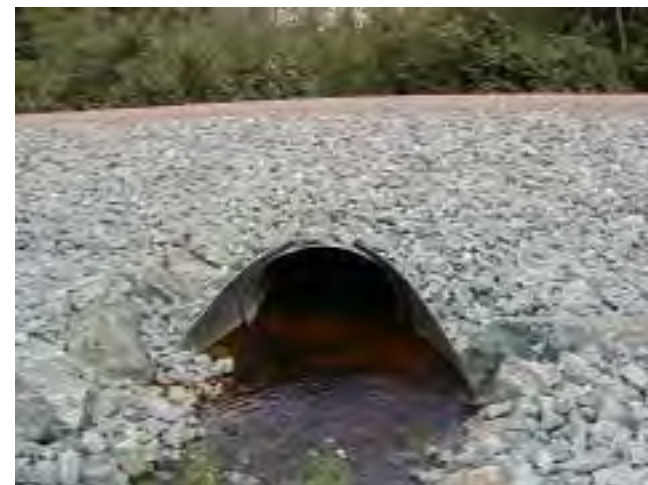
Salmon Trout River Watershed Road Crossing Inventory, Summer 2005 Crossing #29 Salmon Trout River @ Triple A Road T 51 N R 29 W Sec. 11 NW 1/4 of NW 1/4

New crossing installed 4/05, excessive use of rip rap.

Downstream Looking up

Upstream Looking Down
