# MILLECOQUINS RIVER WATERSHED MANAGEMENT PLAN

## **SUPERIOR WATERSHED PARTNERSHIP**

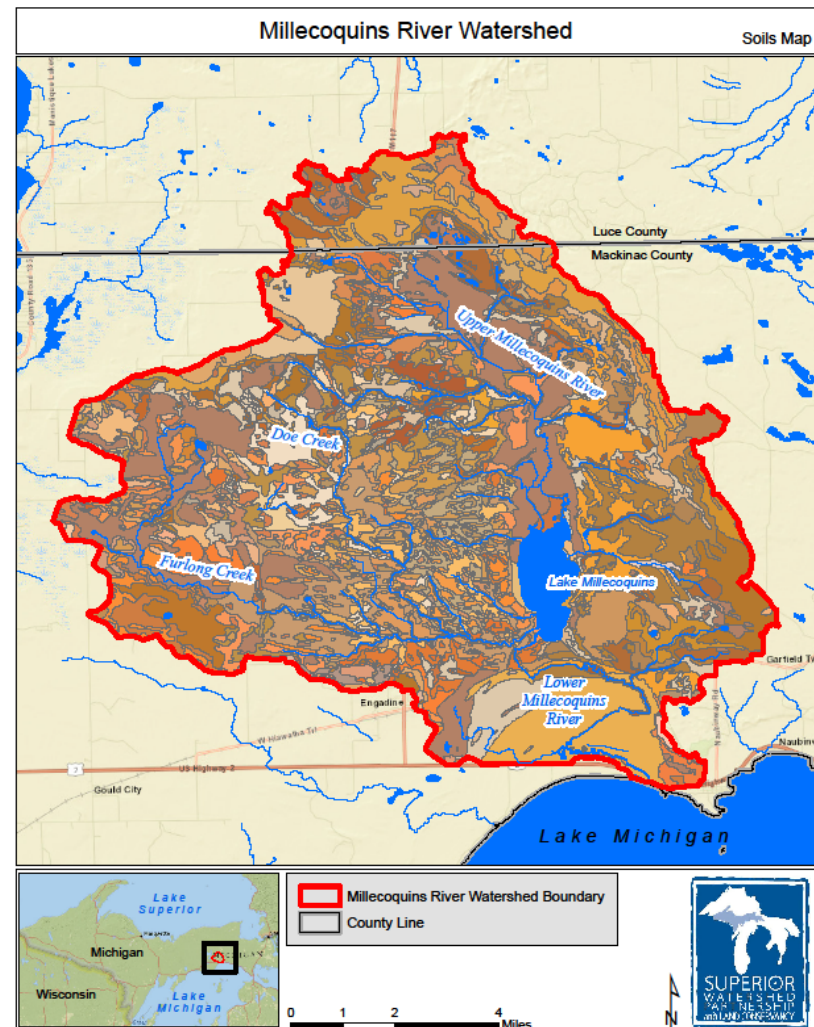
Figure 5. Watershed Soils Map

Interpretive ratings are used to identify the limitations that affect specific uses and to indicate the severity of those limitations. Rating classes are expressed in terms that indicate the extent to which the soils are limited by all of the soil features that affect a specified use or in terms that indicate the suitability of the soils for the use. Terms for the limitation classes include: not limited, somewhat limited, and very limited; or slight, moderate and severe. The suitability ratings are expressed as well suited, moderately suited, poorly suited, and unsuited or as good, fair, and poor (USDA 2003). Soil erosion potential is based on the probability that damage will occur where soils are exposed as a result of management activities. This attribute is directly connected with slope and other attributes of the soil type. The ratings slight, moderate, and severe indicate the degree at which

erosion-control measures should be taken with the severe rating requiring the most precautions (USDA 1997).

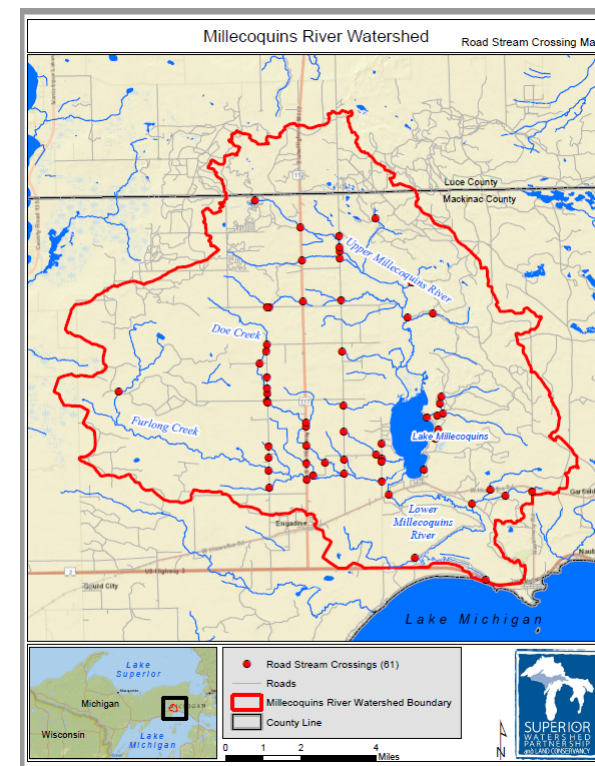
Figure 10. Road/stream crossing inventory map.

Watershed (Figure 10). Data was collected according to the DNR's Great Lakes Road Stream Crossing Inventory Instructions and was uploaded to the Michigan DNR Stream Crossing Viewer database. By clicking on a point, the viewer can see detailed measurements and observations collected by the SWP field technicians and view photos of the site. The inventory data, which is summarized in Appendix A, was used to prioritize replacement of culverts/crossings that are undersized, damaged and/or impeding stream flow and fish passage. Specific prioritization was given to crossings which caused excessive sedimentation and posed concerns for nonpoint source pollution. The prioritized crossings are summarized in Appendix B, including their current conditions and recommended BMPs.

creek's upstream and downstream, and road in both directions. Data from the inventory was entered into the DNR Stream Crossing Inventory and findings are summarized in Appendix A. Results indicated that 56 of the 61 assessed crossings were found to be generating erosion in the watershed. Six of the crossings were found to be creating ponding as well (at the time of the assessment, these six streams were at bankfull or just under bankfull). These phenomena negatively impact water quality; sediments entering the watershed destabilize hydrology necessary for healthy fish habitat while also carrying excess nutrients, causing algal blooms. Similarly, pooling caused by road-stream crossings increases water temperature, providing tepid, still water for algal development.

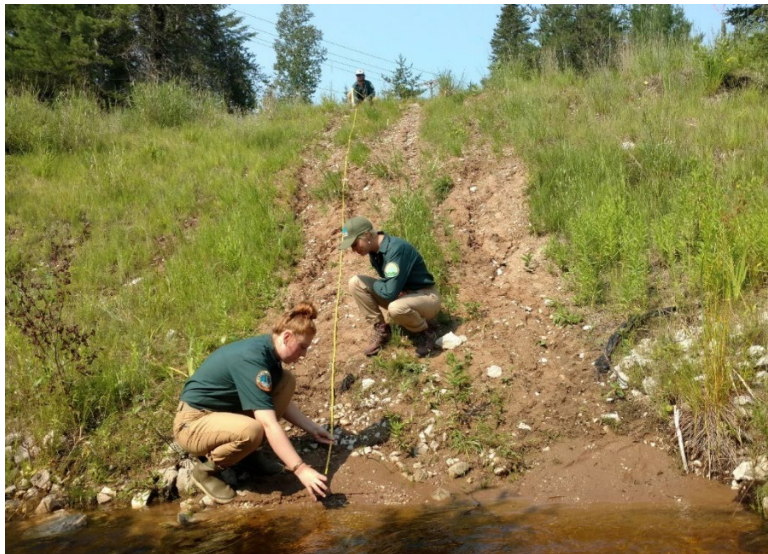
Photo: GLCC field technicians assessing erosion at an unregulated stream ford
